# Homespect LLC

## Commercial Inspection Report

600 Commercial Way, Your Town NJ  
Inspection prepared for: Commercial Client  
Inspection Date: 8-16-2010 Time: 10:00 AM Size: 42, 315 sf  
Weather: Cloudy, 90's

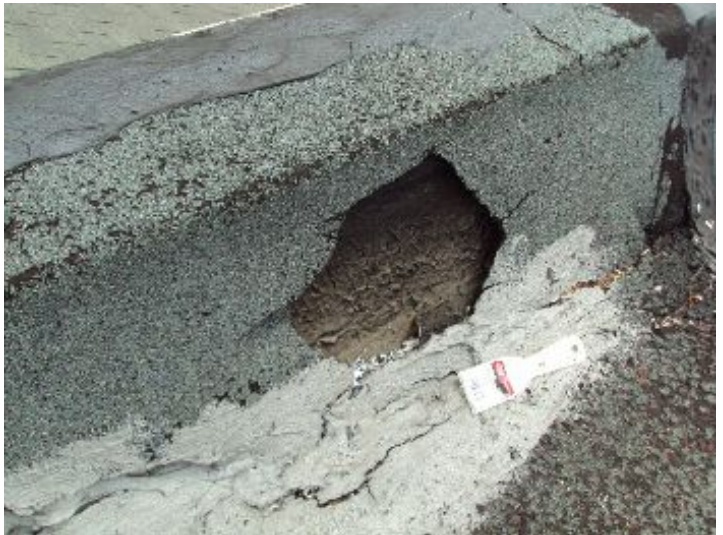
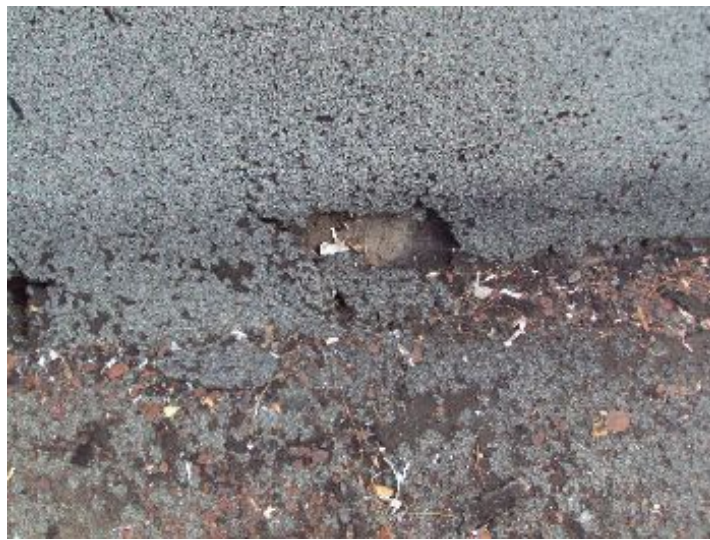
- Severe "alligatoring" of the built up roofs asphalt "flood coat" has left exposed membrane. This condition will surely lead to leakage into the interior.

- Major areas of deterioration are noted to the roof covering. The roof appears to be beyond its useful life. We recommend budgeting for replacement of the roof system

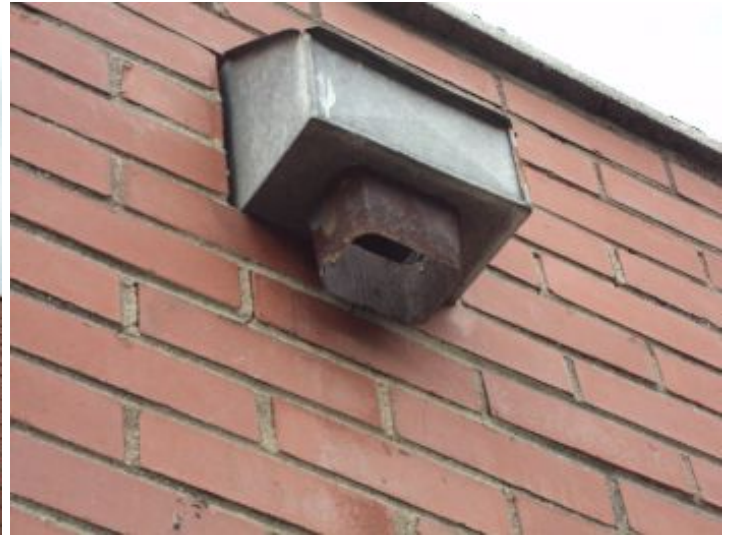
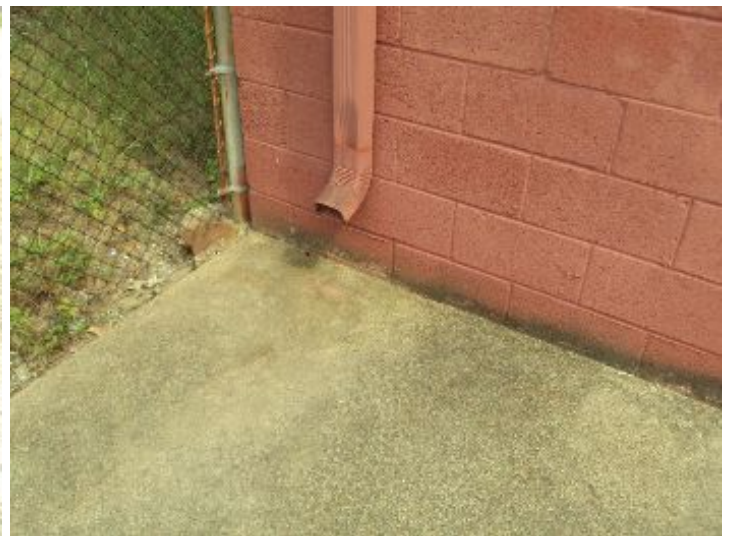
- Roof drains observed.
- Roof scupper and downspout.
- Missing downspouts observed. Suggest downspouts be installed to ensure proper drainage away from the foundation.
- Downspout discharges water at foundation. Recommend installation of extension to ensure proper drainage away from foundation to prevent seepage.

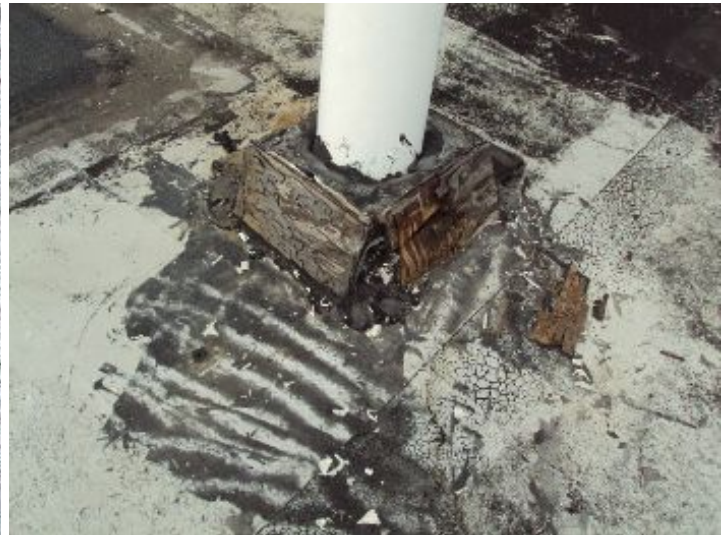
- Some of the roof top areas could not be inspected due to decaying roof decking creating an unsafe situation.
- Roof top A/C unit curbs noted.
- Pitch pocket noted.
- Many of the roofs penetrations have deteriorated to the point of being ineffective. We recommend repair or replacement by a qualified roofing contractor.

Pitch Pocket?

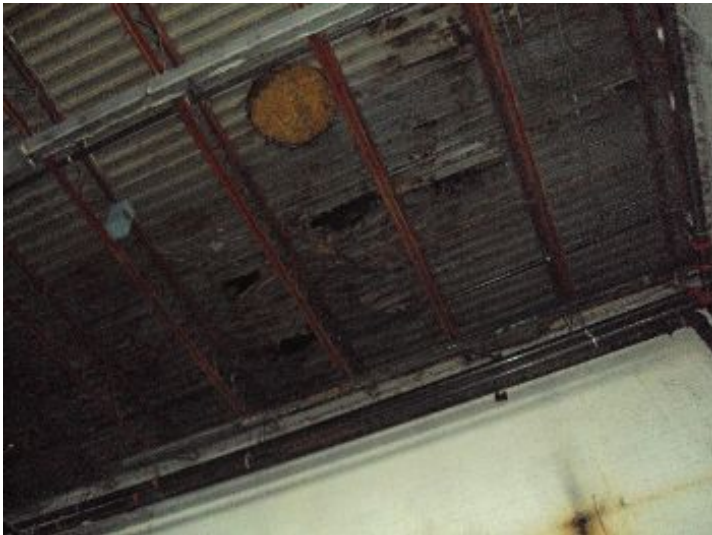
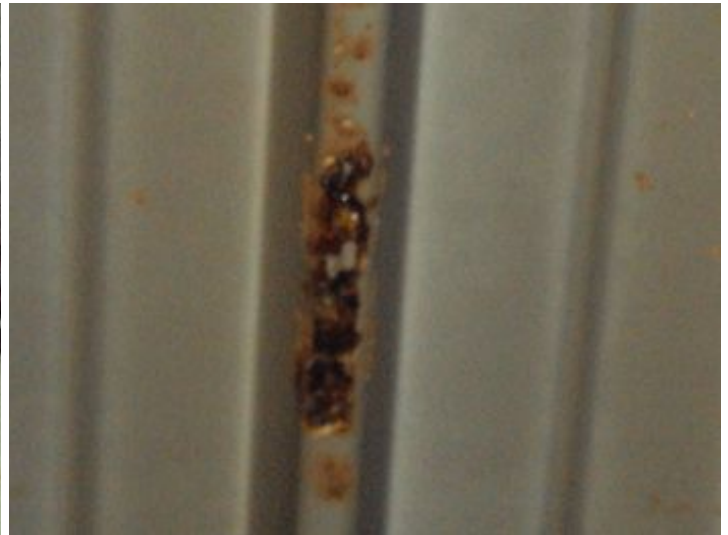
- There are active roof leaks noted throughout the roof system. The roof appears to be at the end of its useful life. We recommend having a qualified roofing contractor provide estimates to replace the roof.

Active leak

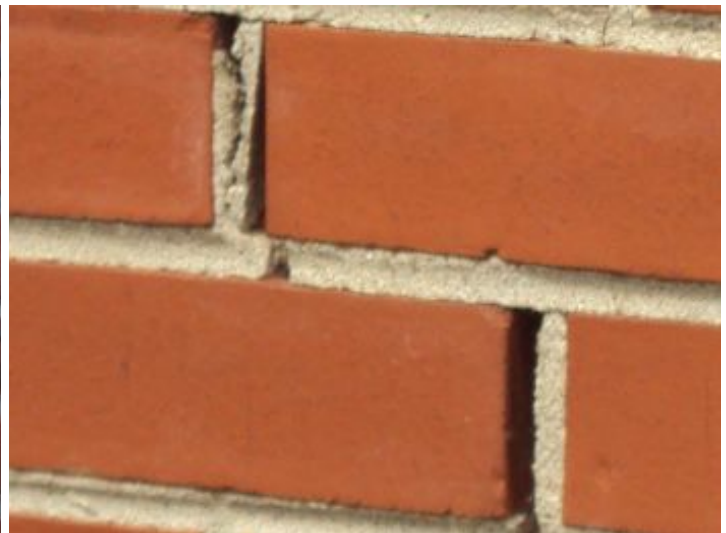
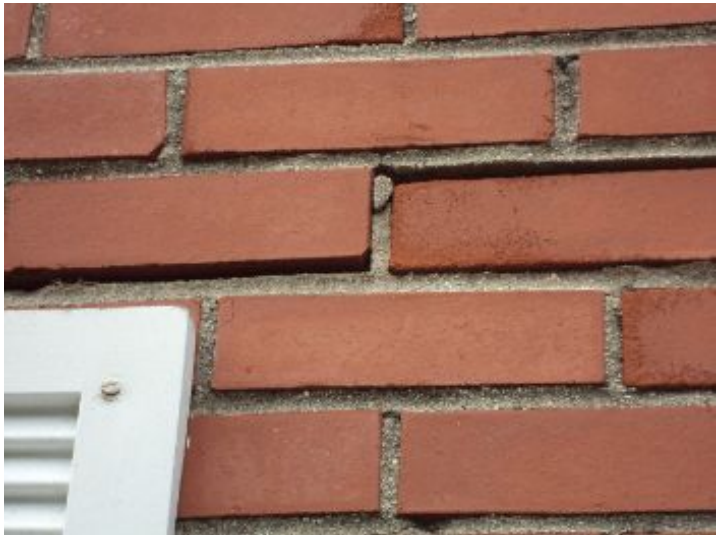
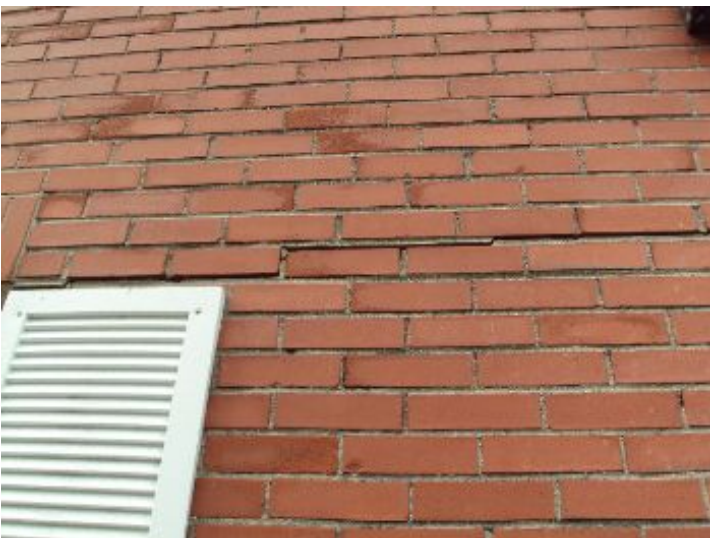
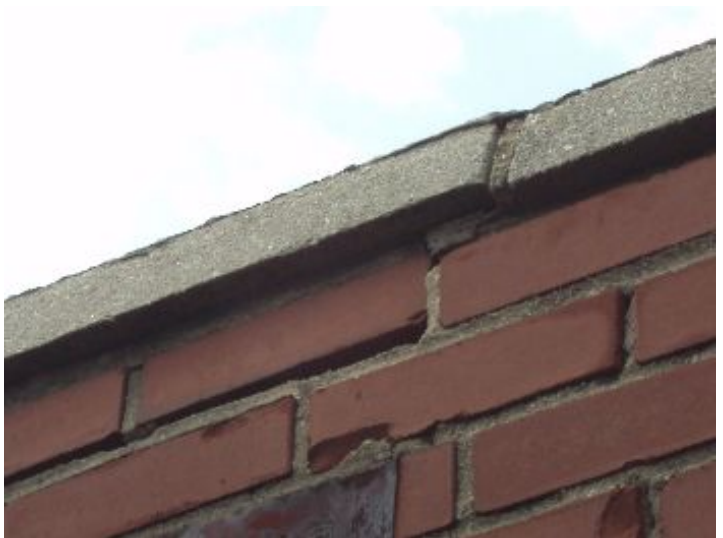
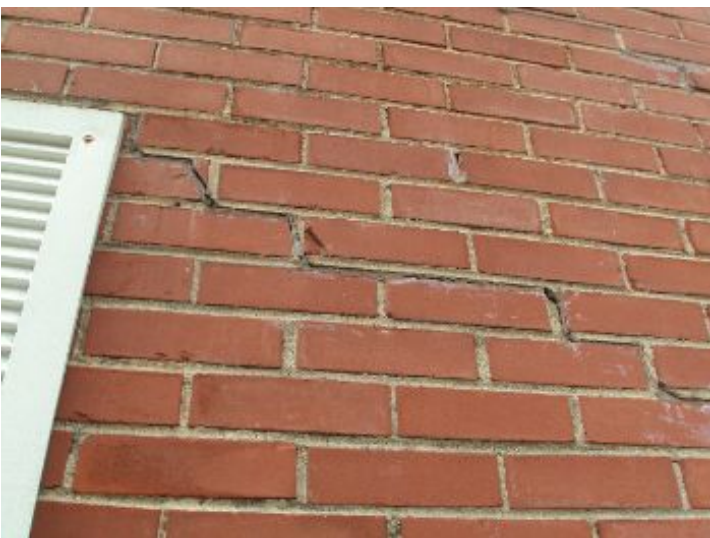
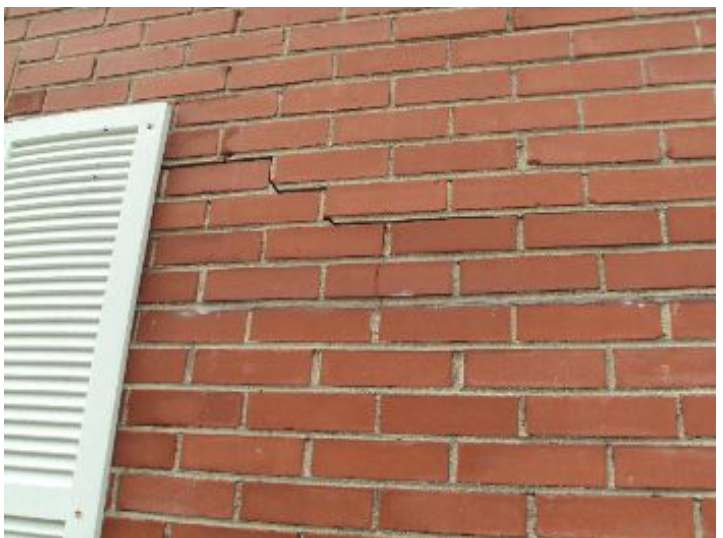
- Brick exterior noted.
- Concrete block exterior with paint finish noted.
- Step cracks and cracks at the window lintels are noted at the brick veneer. This is usually caused by uneven settlement in the veneer. Due to the exterior roof drainage problem, subsoil erosion is most likely the cause. We recommend having a qualified masonry contractor provide cost estimates and perform the necessary repairs.

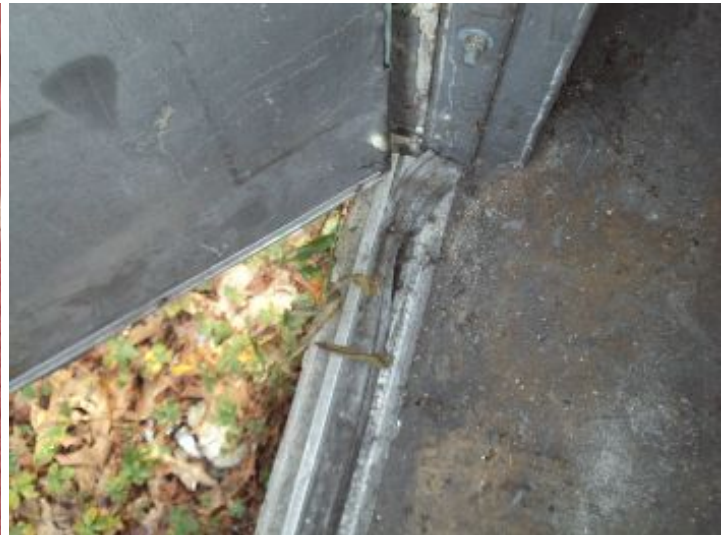
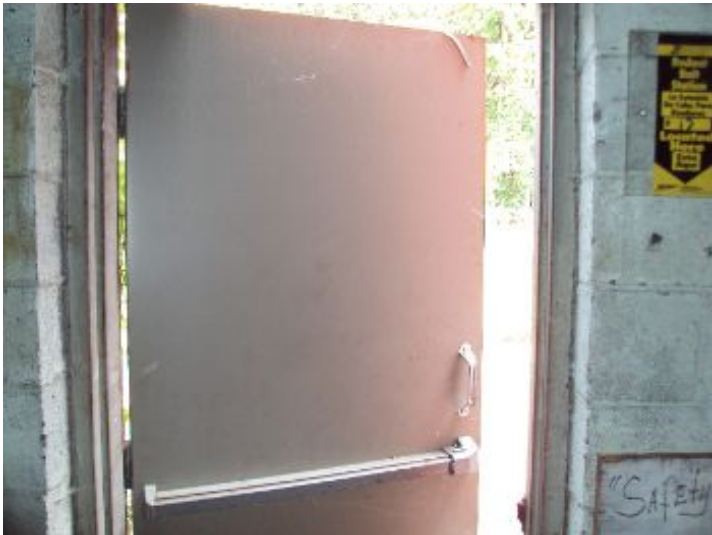
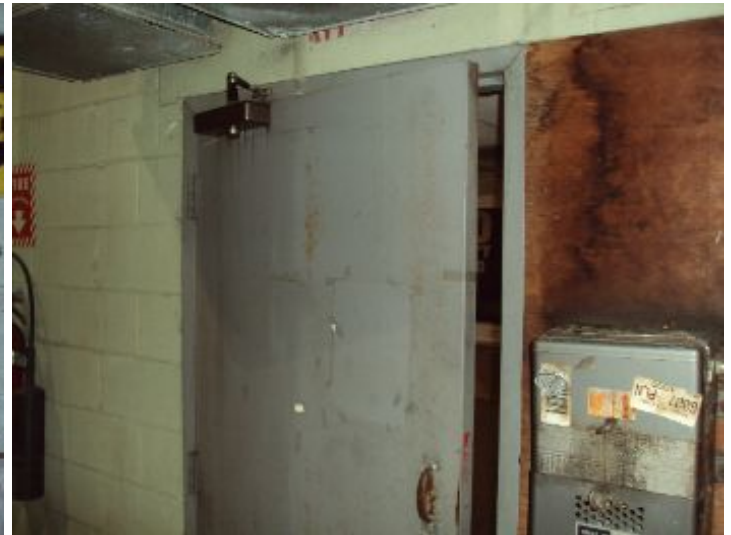
- Main Entry door is a wood door with a painted finish.
- Fascias are aluminum clad wood.
- All of the exterior hinged emergency egress doors are out of adjustment, rubbing, or have incomplete or damaged hardware items. We recommend having a qualified door contractor provide cost estimates and perform the necessary repairs.

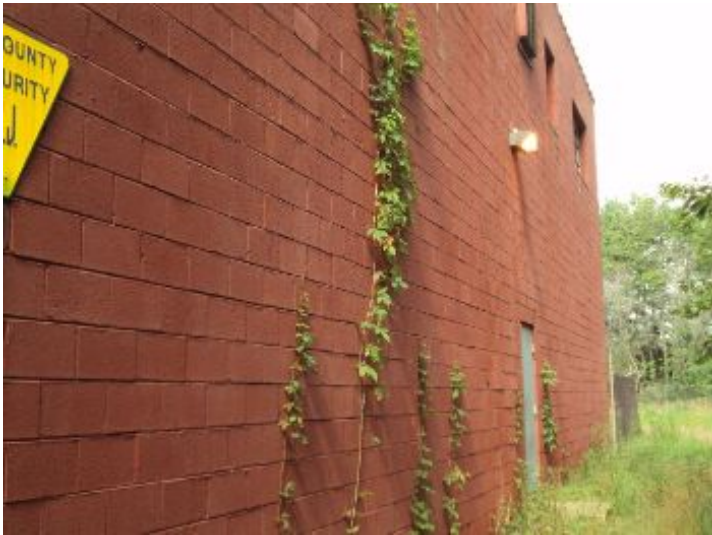
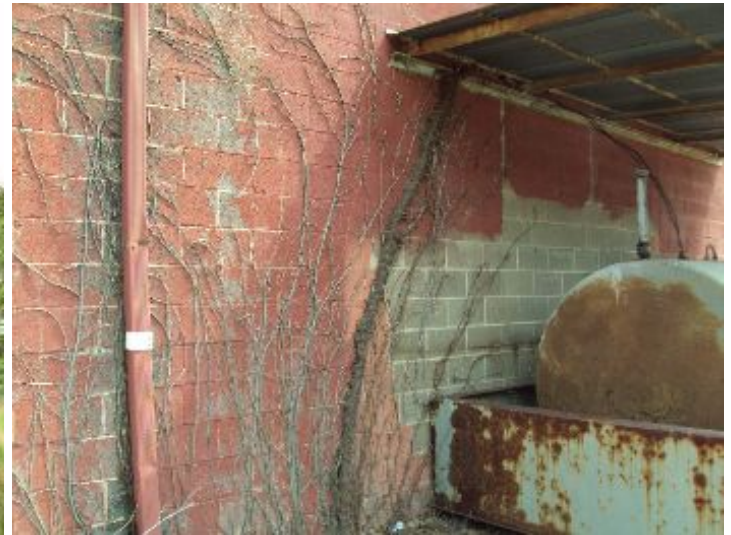
- Vegetation observed to be too close to, touching, or growing on siding . Condition can promote excessive damage and deterioration by movement of branches, root growth and/or attachment, moisture retention, and can promote pest infestations. We recommend trimming away or removing the vegetation affecting the structure to preserve the life of the building.

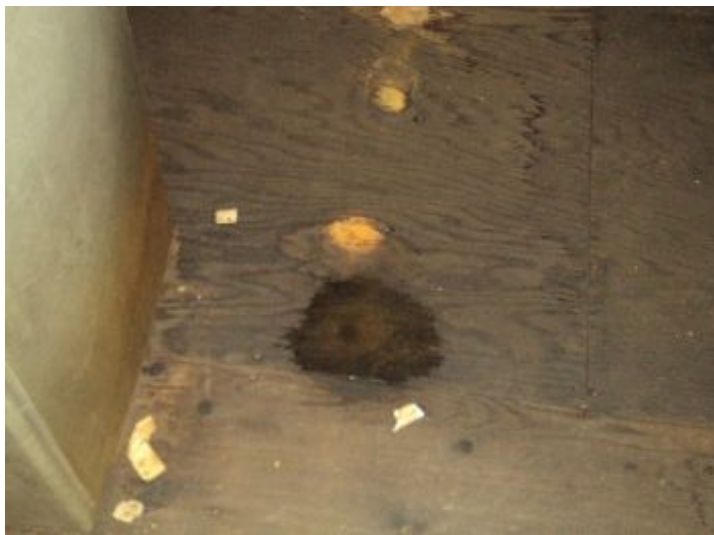
- Due to the prior and the on going roof leaks, the structure may be showing signs of decay on the upper level plywood floor. There are numerous damaged ceiling tiles on the lower level. We recommend having a qualified contractor perform a more invasive evaluation of the structure which is beyond the scope of this inspection.

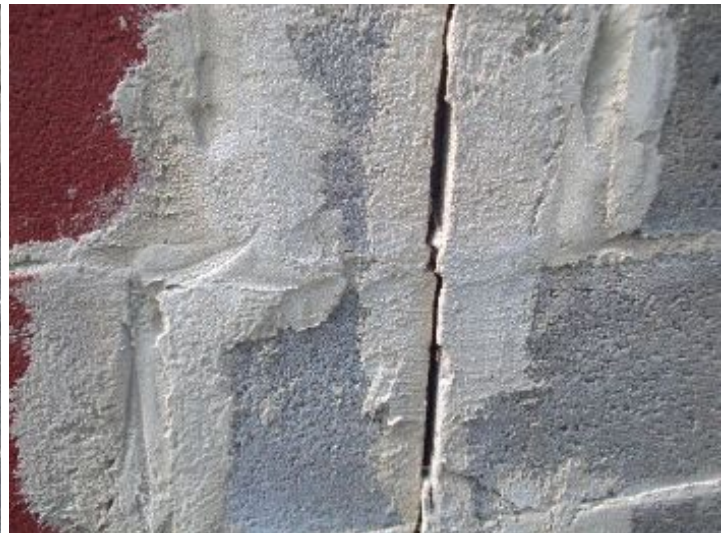
Poor workmanship

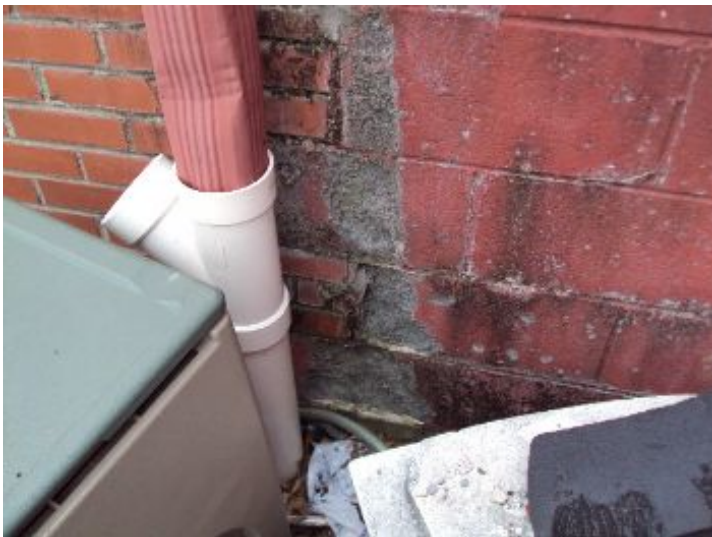
Severe spalling

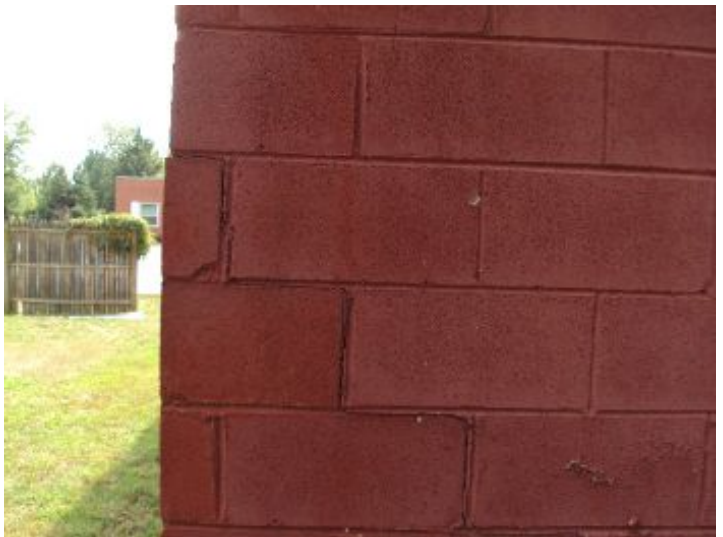
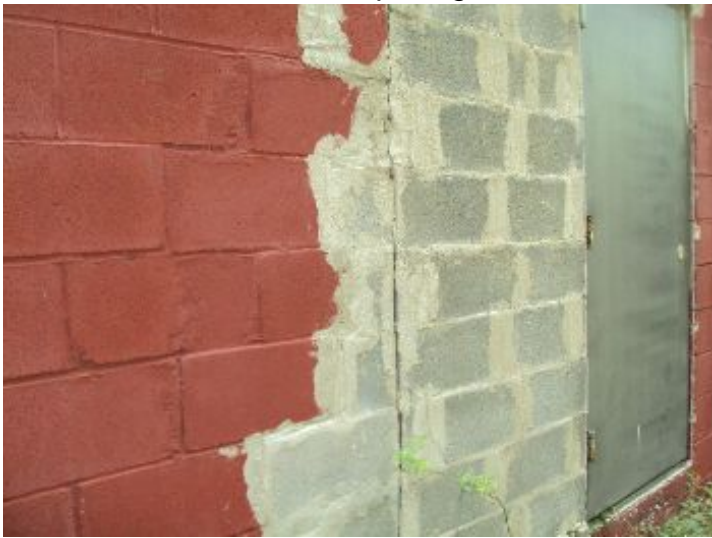
poor quality masonry

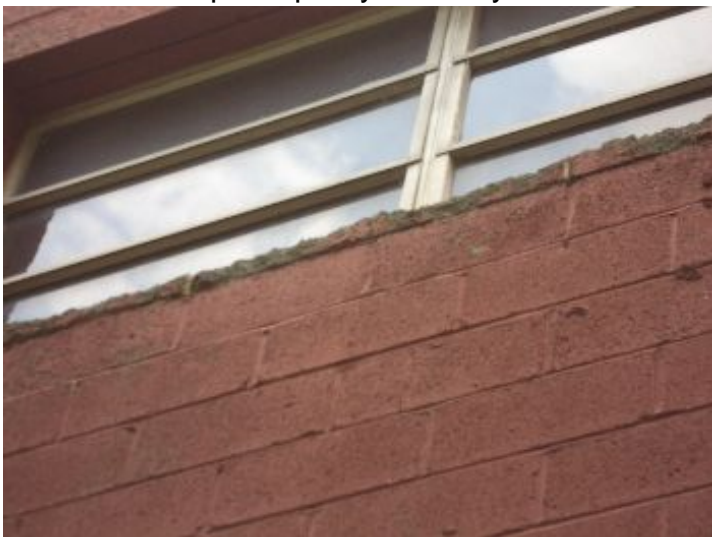
Severe spalling

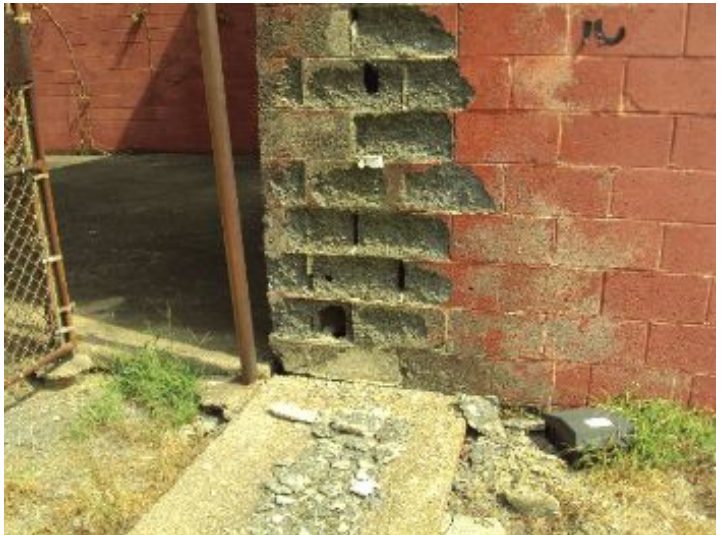
Spalling

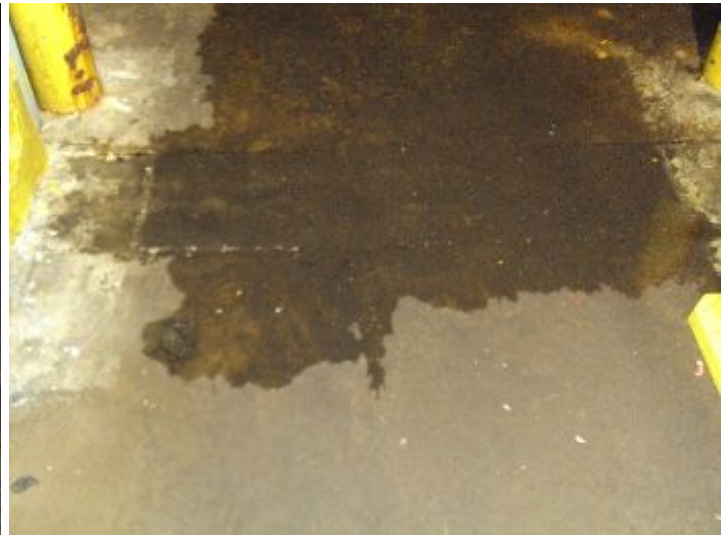
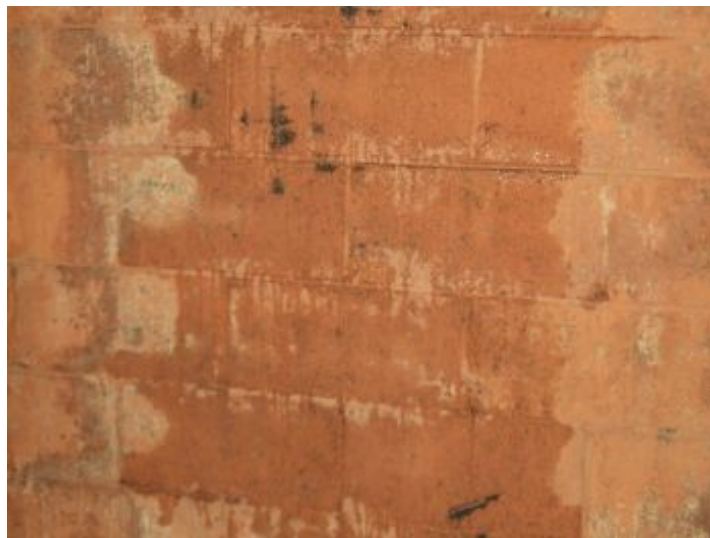
Observations:  
• Efflorescence observed; this is a mineral deposit left behind from exterior water infiltration.  
• There is evidence of moisture penetration in the manufacturing area. We recommend having a qualified contractor repair as necessary.

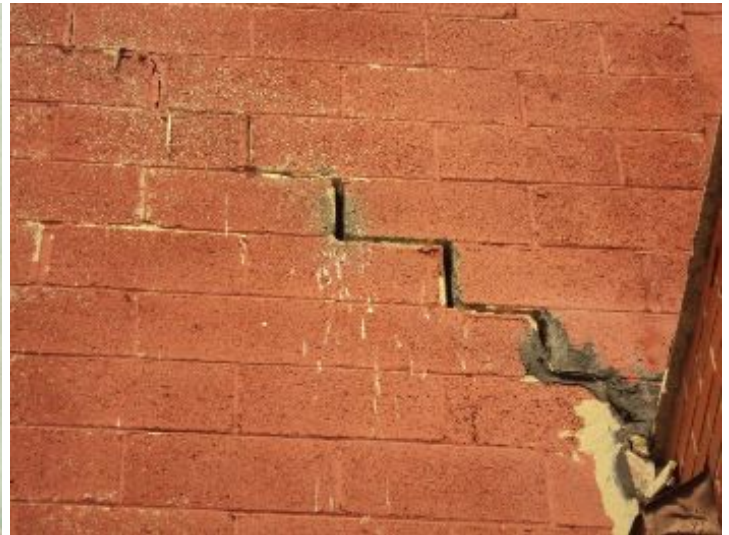
Observations:  
• Step cracks in the corners of the foundation are present. This is an indication of irregular settlement and movement.

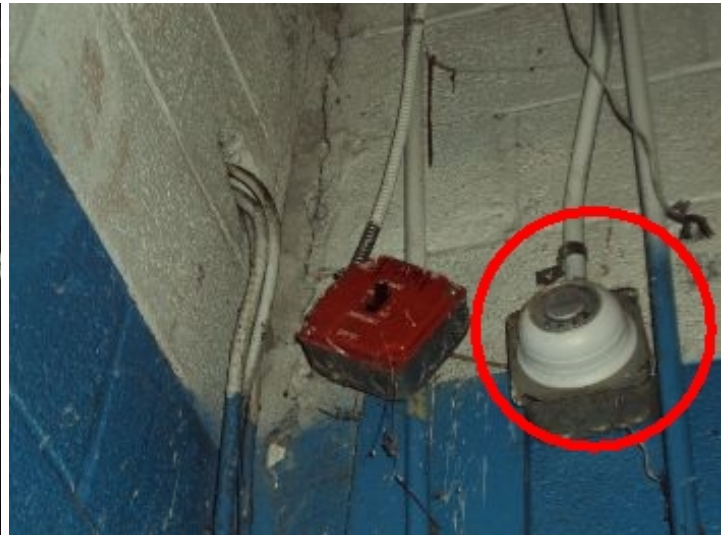
- Office area:
  - Natural gas fired unit.
  - Remote thermostat
  - The heating system was operable at the time of inspection using normal operating controls.
- Manufacturing area:
  - Natural gas fired unit.
  - Fuel oil fired unit.
  - Remote thermostat
  - No thermostat noted.
  - The main oil-fired furnace in the manufacturing area runs without a thermostat. The method of turning the unit on and off is to use the circuit breaker that controls it. Circuit breakers are not intended to be used as on-off control switches. This will probably lead to failure of the breaker itself. We recommend having a qualified contractor install proper operating controls for the unit.

Storage areas thermostat

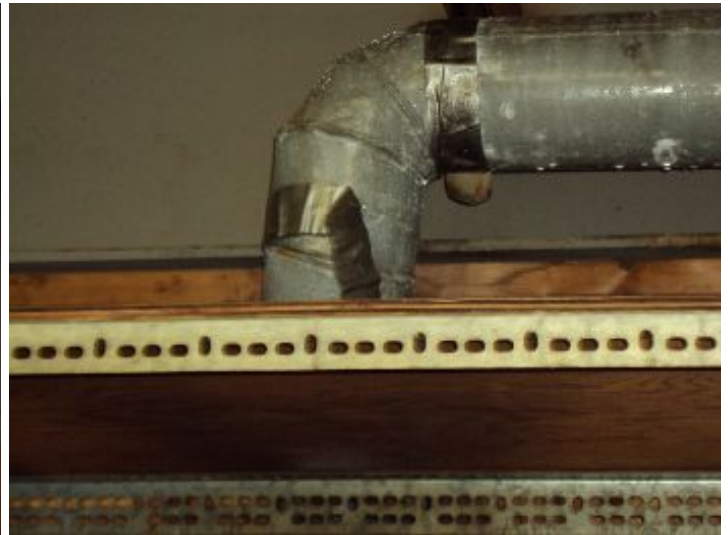
- Much of the ductwork stemming from the roof top HVAC units is sealed at the connections with cloth backed duct tape. This tape is known to deteriorate and become ineffective over time. We recommend having a qualified HVAC contractor repair all joints in the ductwork that are affected by this tape with a duct sealing mastic.

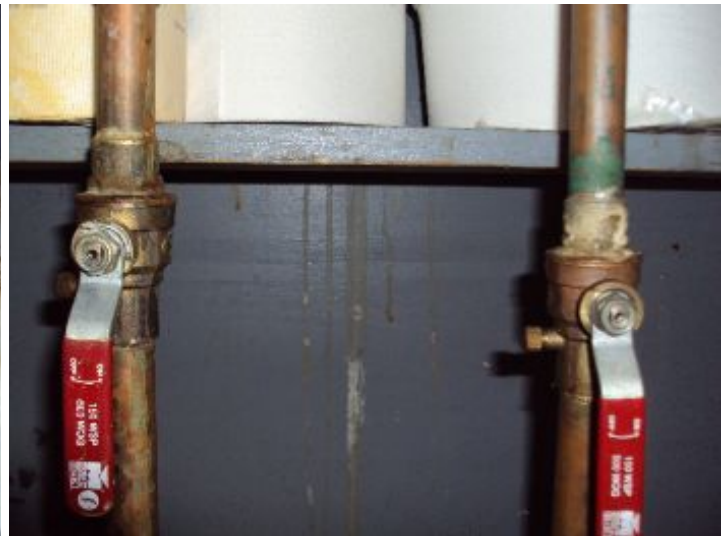
- The water heater is a 40 gallon electric model that is located in the mens locker room in the utility closet. The exact age could not be determined from the data plate. The unit although functioning as intended at the time of inspection however, shows the wear and tear that could be expected from a unit that has reached the end of its useful life expectancy. We recommend having a qualified plumbing contractor provide replacement options and cost estimates.
- The water heater that is located in the break room does not have the proper support under it. The cabinet that it sits in is deteriorating and failing.

Prior leaks and deterioration

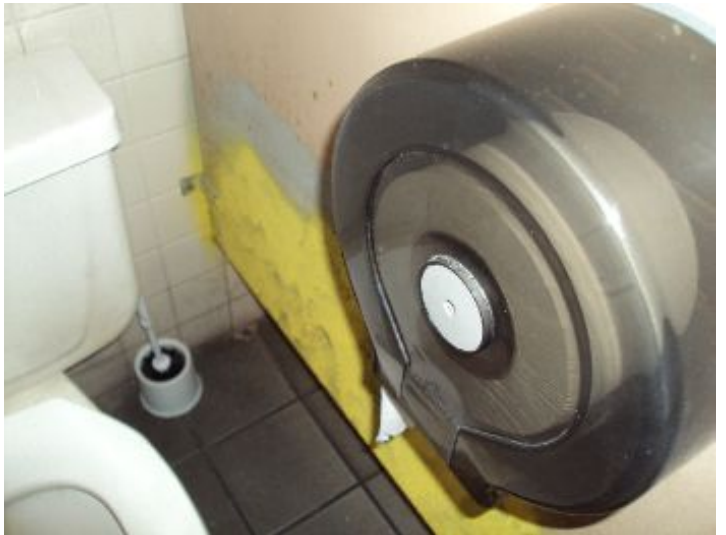
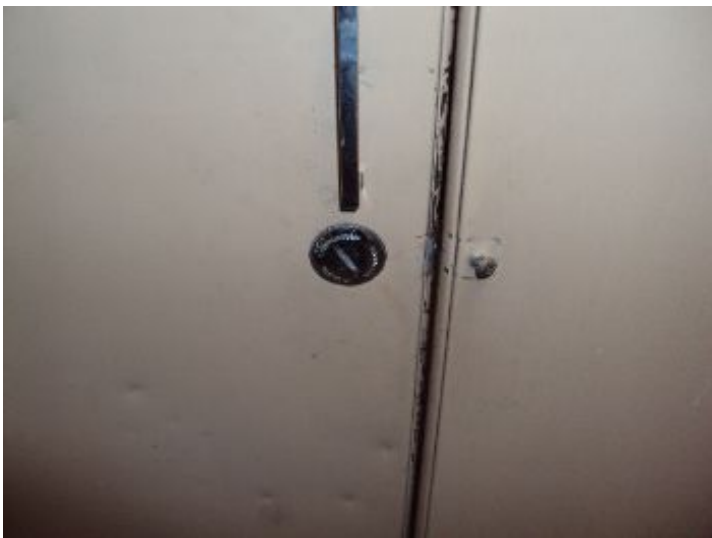
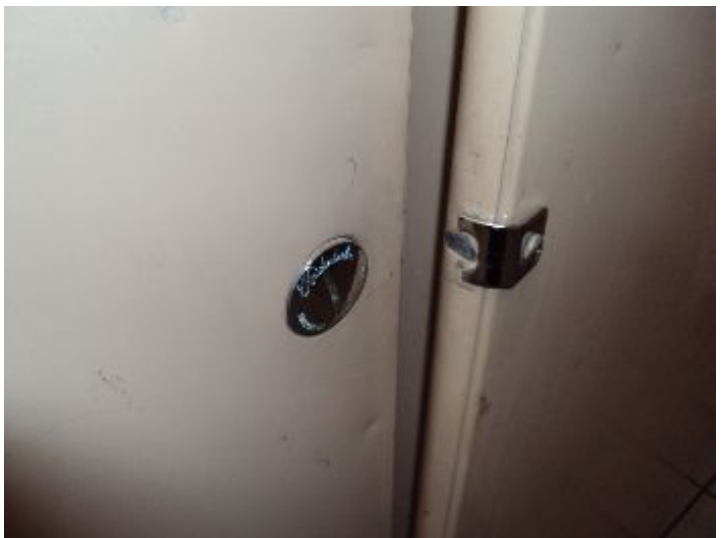
- The toilet partition doors in the Mens Locker Room do not latch securely. One door has a broken strike plate and the other has a missing strike plate.
- Many of the toilet partitions in the Men's and Women's Locker Rooms are damaged by rust and corrosion. We recommend budgeting for replacement of these.

Toilet partition door doesn't latch (Mens Locker Room)

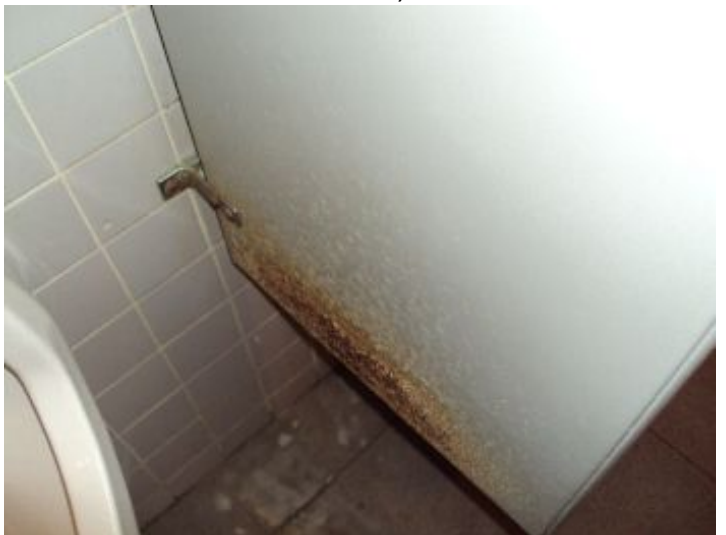
Toilet partition damage

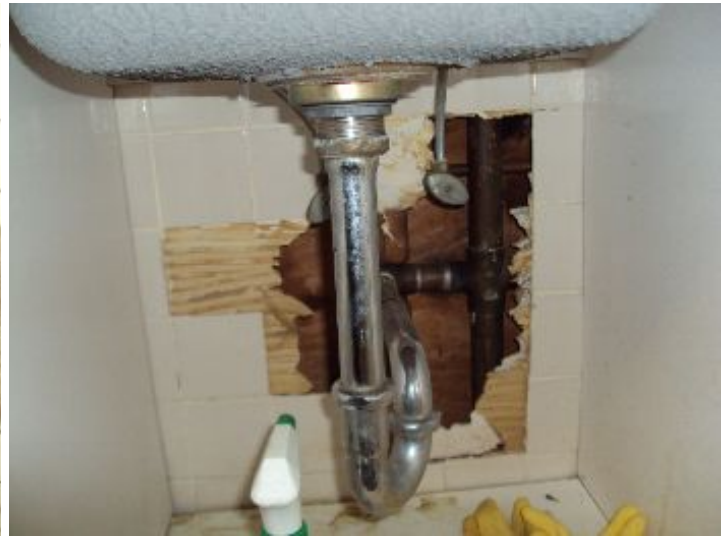
Evidence of a prior repair (Mens Locker Room)

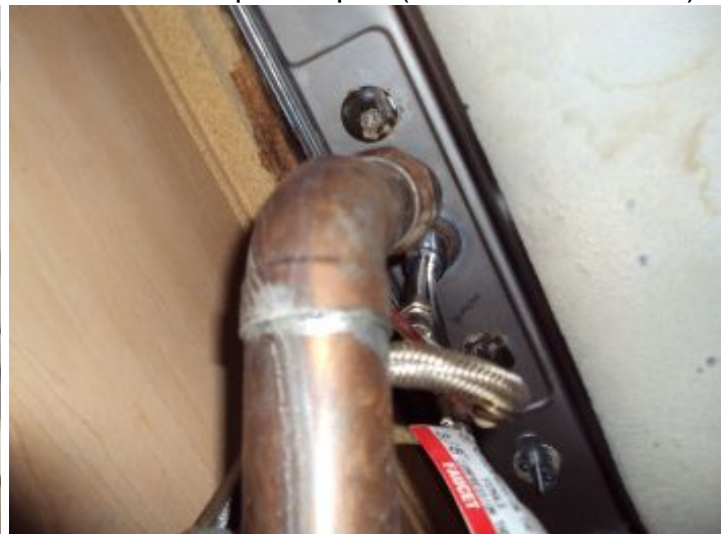
Air admittance vent. No AAV installed.

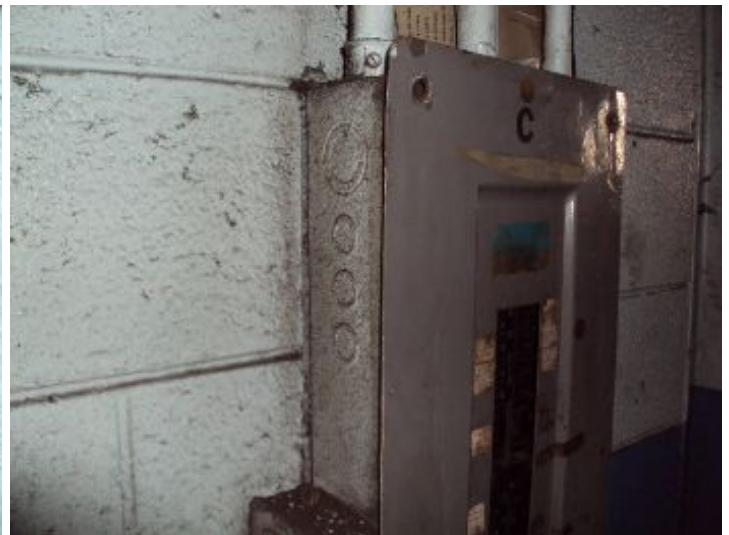
Panel cover screws missing

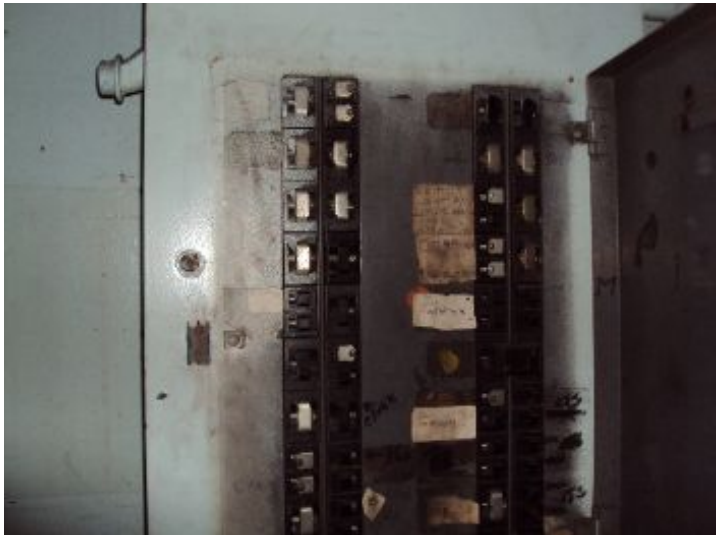
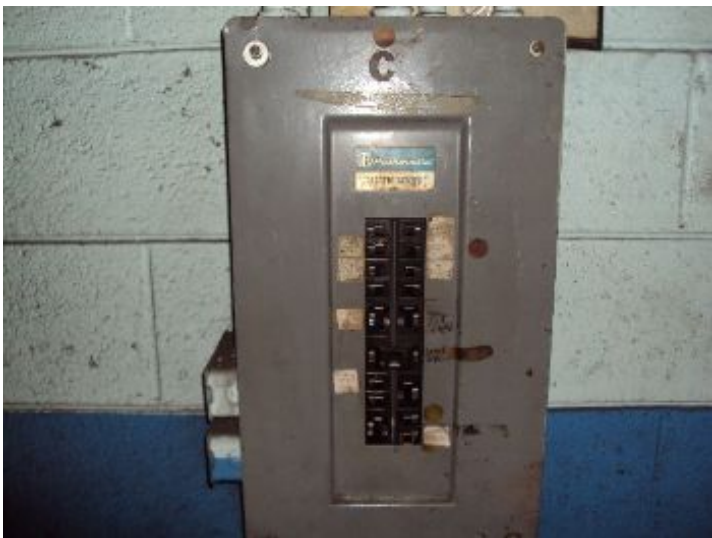
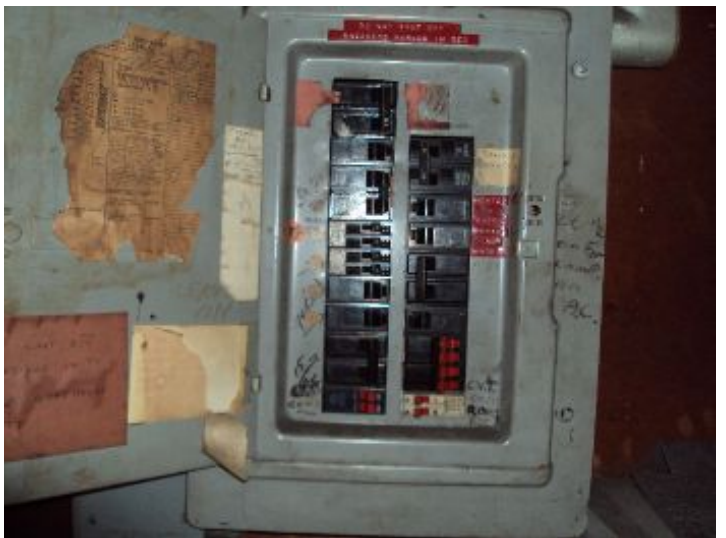
- Most of the panels are poorly or incorrectly labeled. We recommend having a licensed electrician trace all circuits and properly label all panels.

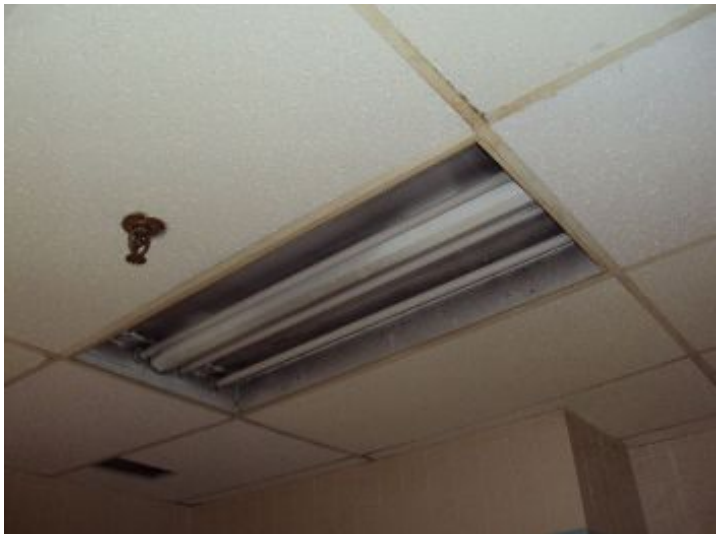
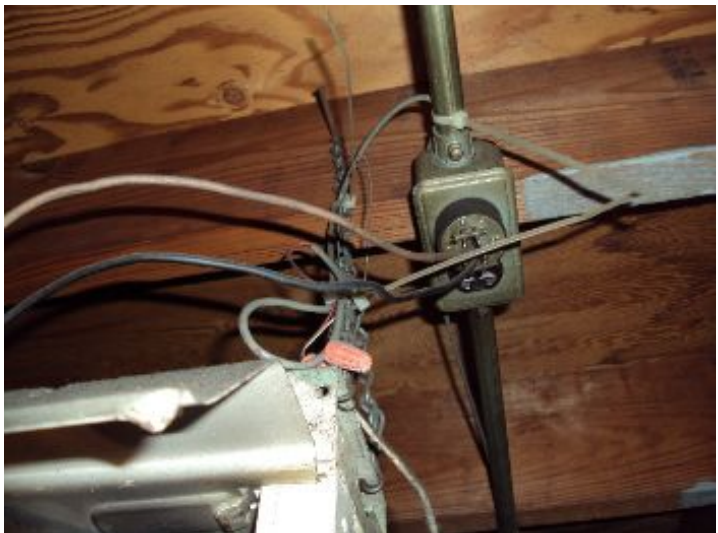
- A large portion of the lighting in both the office area and the manufacturing area are not working , or in some state of disrepair. We recommend having a licensed electrician repair and or replace as necessary.

Improper wiring

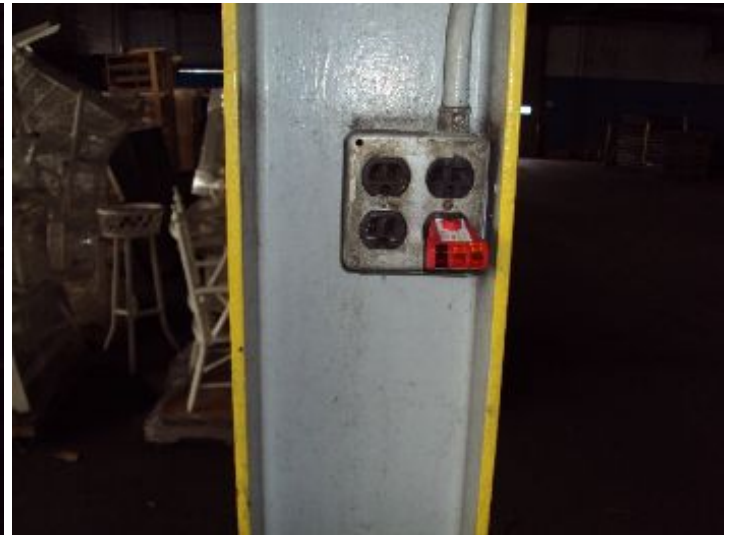
Dead outlet

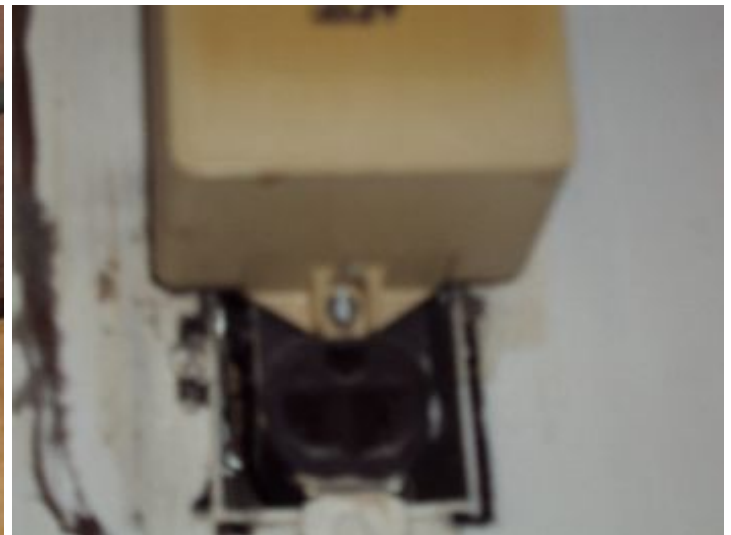
• Outlets in both the office and the manufacturing space are missing cover plates. This is a potential safety hazard. We recommend replacing the outlet covers.

Missing cover in office space

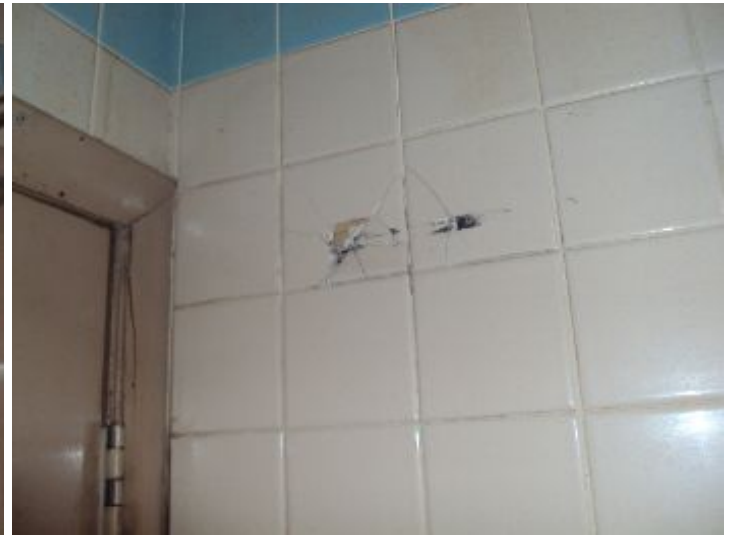
Damage to ceramic tile from door closer arm

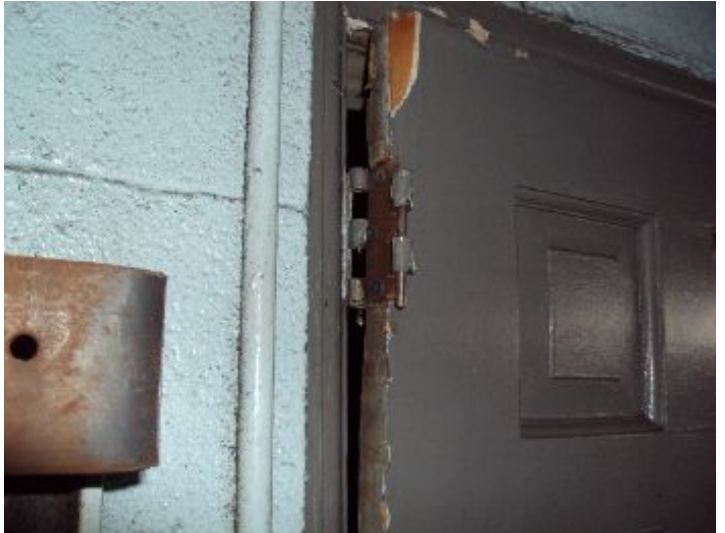
Decayed door frame

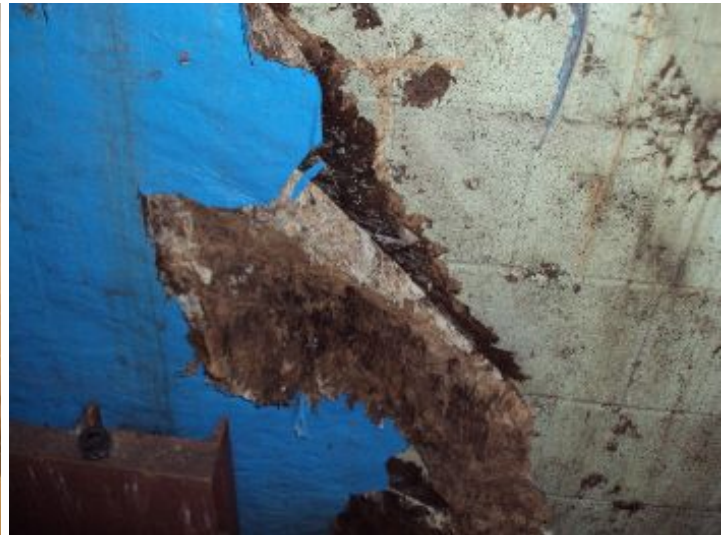
The wood protective "Wainscot" on the exterior walls in the manufacturing area have been water damaged and are deteriorating. There is evidence of an organic substance consistent with mold in some areas. We recommend removing the wainscot and performing a mold test if necessary to confirm the presence of mold.

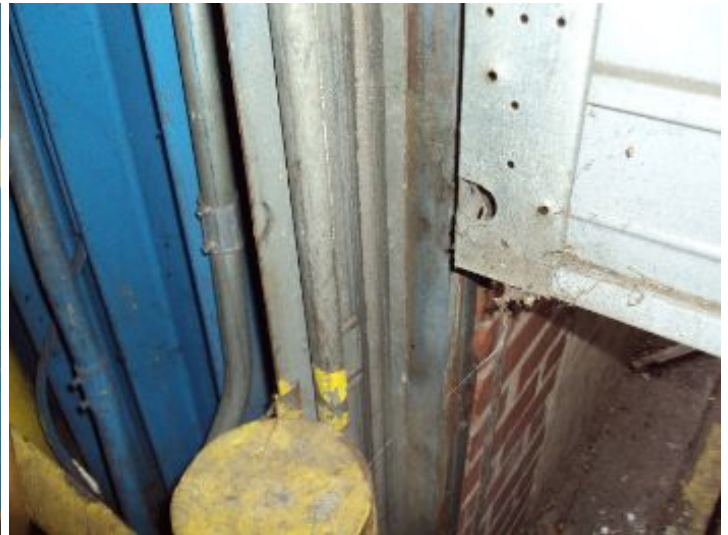
• The loading dock garage doors did not work smoothly and required a great deal of force to operate. Broken hardware is noted on one door. We recommend having these doors serviced by a qualified overhead door contractor to bring them back into working order.

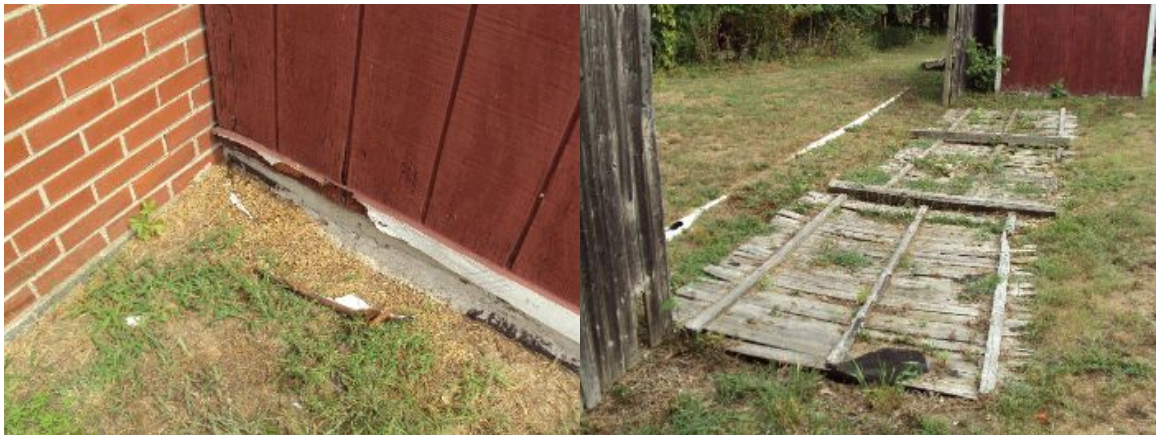
Accessory building

Broken fencing
