# Homespect LLC

## Commercial Inspection Report

600 Commercial Way, Your Town NJ  
Inspection prepared for: Commercial Client  
Inspection Date: 8-16-2010 Time: 10:00 AM Size: 42, 315 sf  
Weather: Cloudy, 90's

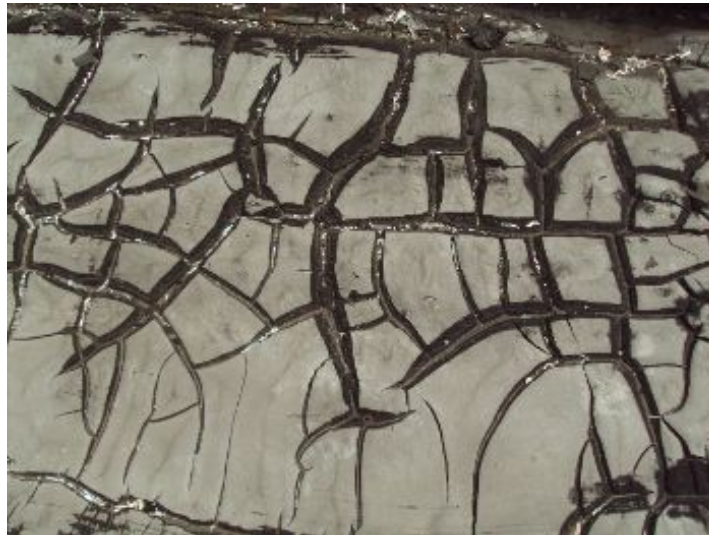
- Major areas of deterioration are noted to the roof covering. The roof appears to be beyond its useful life. We recommend budgeting for replacement of the roof system

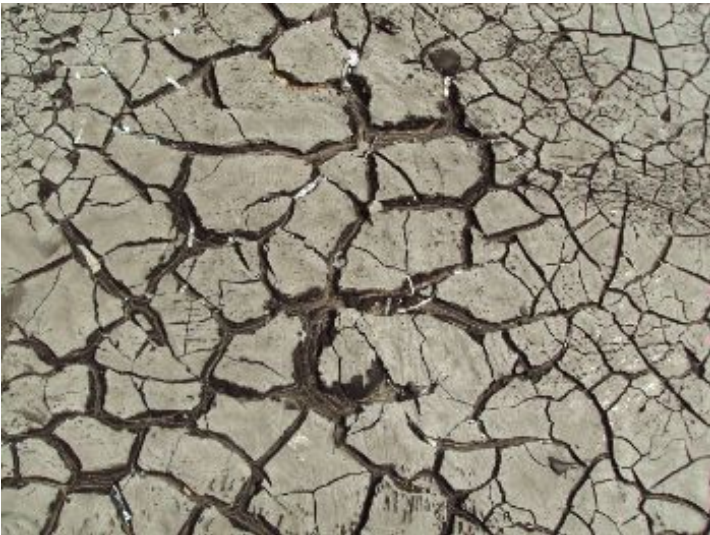
3. Presence of Exposed Membrane

- Severe "alligatoring" of the built up roofs asphalt "flood coat" has left exposed membrane. This condition will surely lead to leakage into the interior.

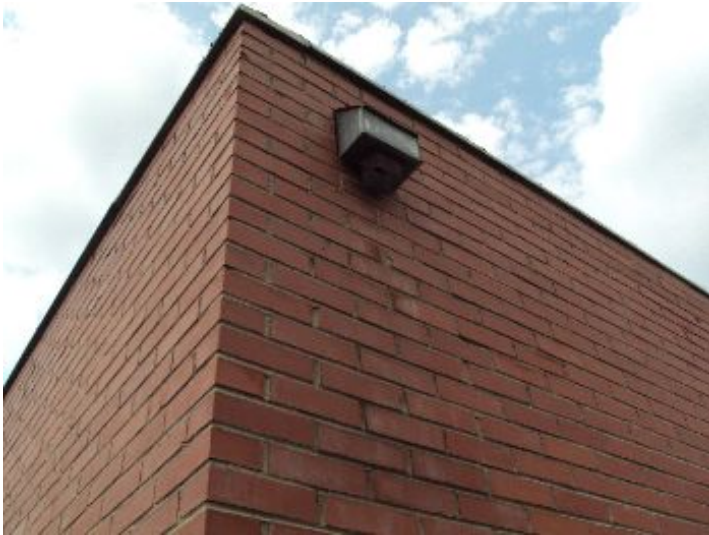
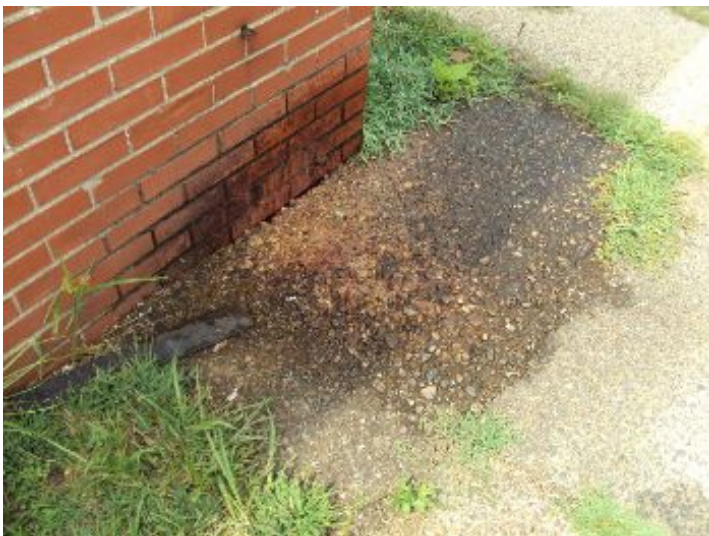
- Roof drains observed.
- Roof scupper and downspout.
- Missing downspouts observed. Suggest downspouts be installed to ensure proper drainage away from the foundation.
- Downspout discharges water at foundation. Recommend installation of extension to ensure proper drainage away from foundation to prevent seepage.

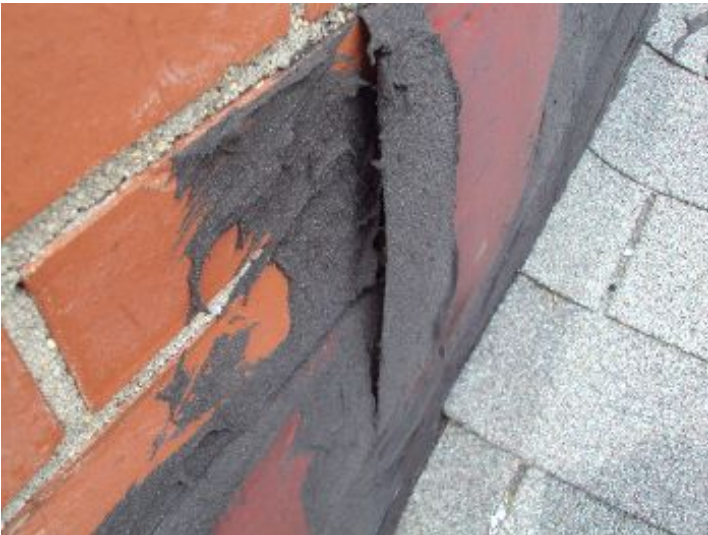
Pitch Pocket?

- Some of the roof top areas could not be inspected due to decaying roof decking creating an unsafe situation.
- Roof top A/C unit curbs noted.
- Pitch pocket noted.
- Many of the roofs penetrations have deteriorated to the point of being ineffective. We recommend repair or replacement by a qualified roofing contractor.

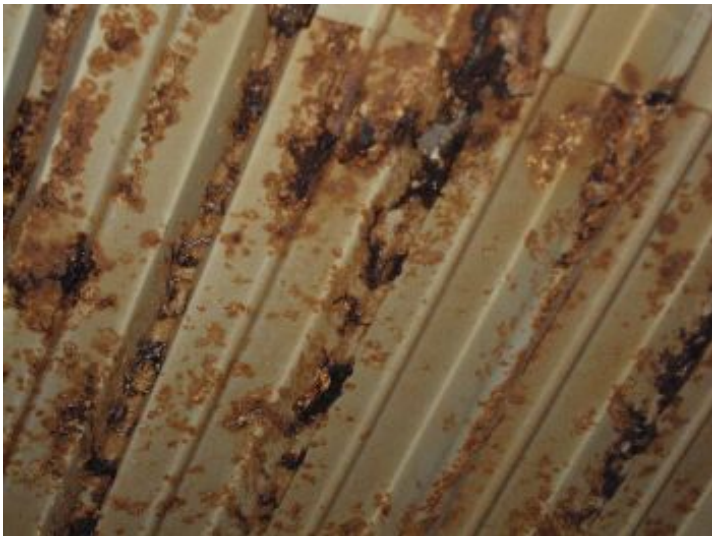
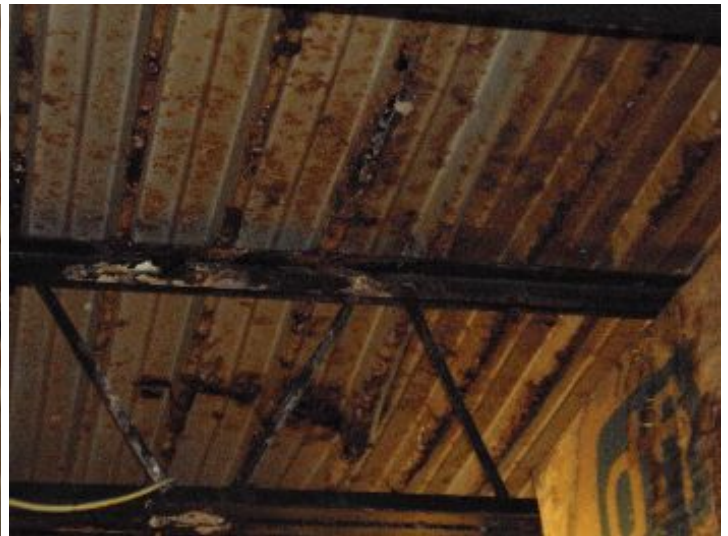
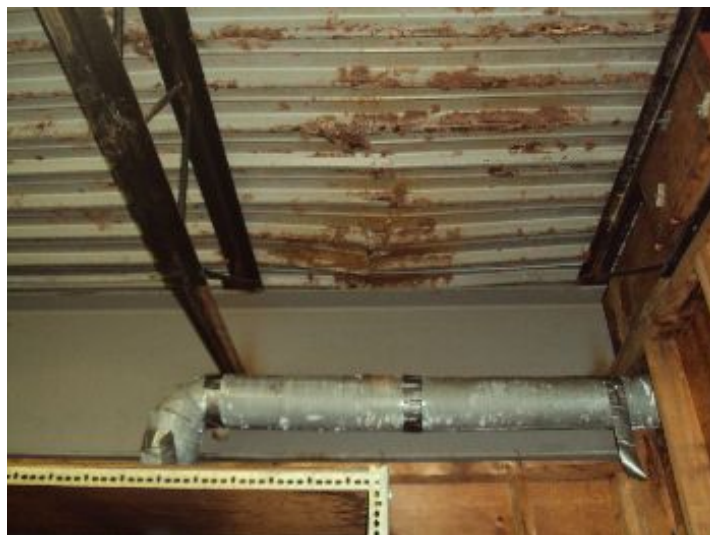
Active leak

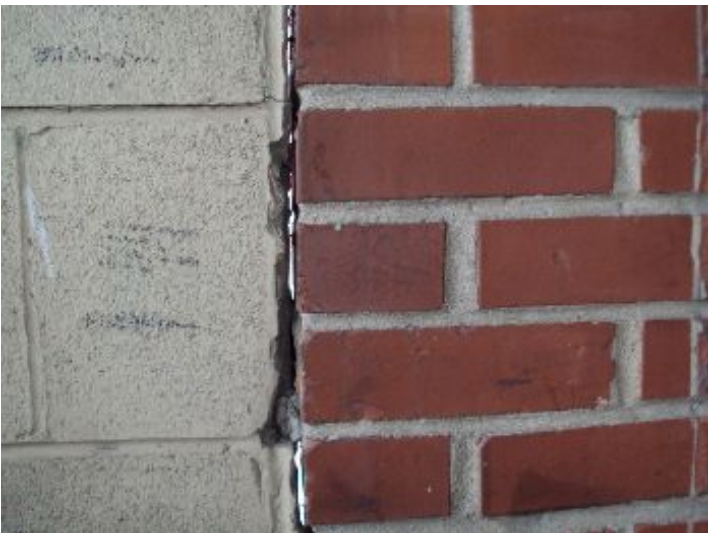
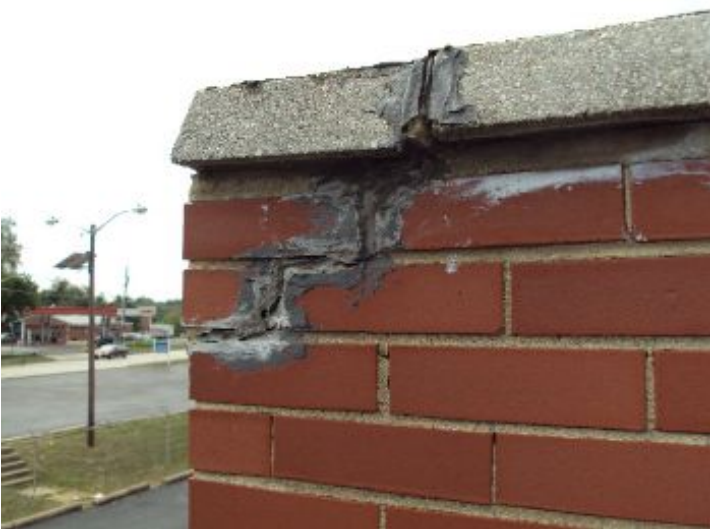
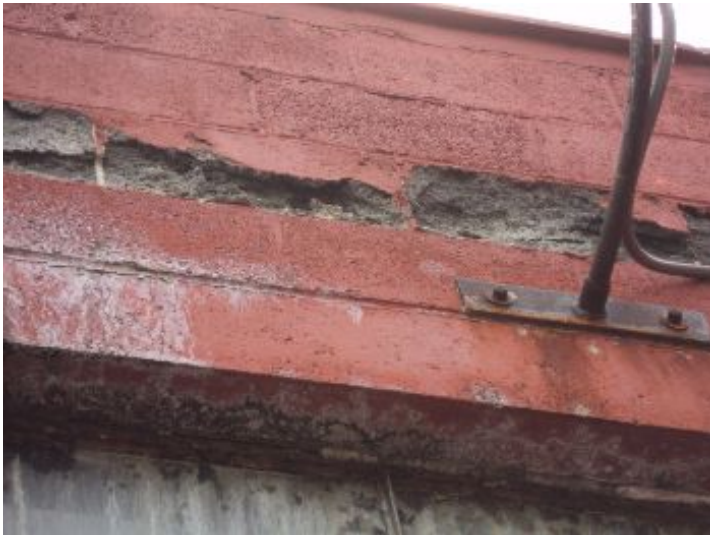
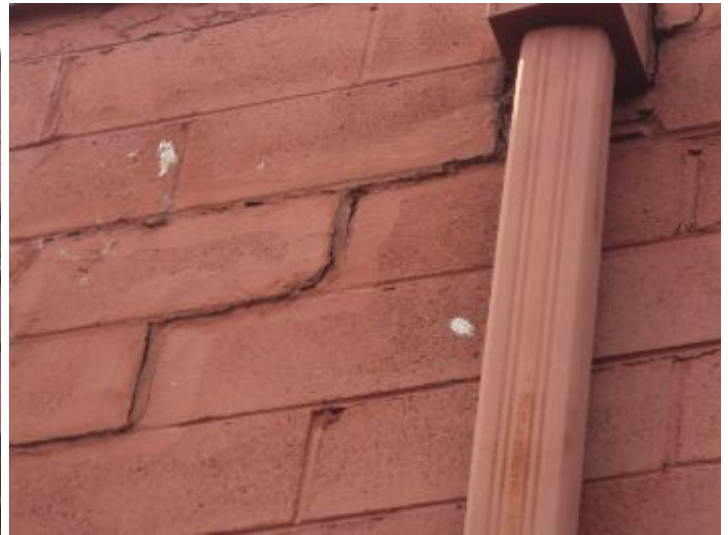
- Brick exterior noted.
- Concrete block exterior with paint finish noted.
- Step cracks and cracks at the window lintels are noted at the brick veneer. This is usually caused by uneven settlement in the veneer. Due to the exterior roof drainage problem, subsoil erosion is most likely the cause. We recommend having a qualified masonry contractor provide cost estimates and perform the necessary repairs.

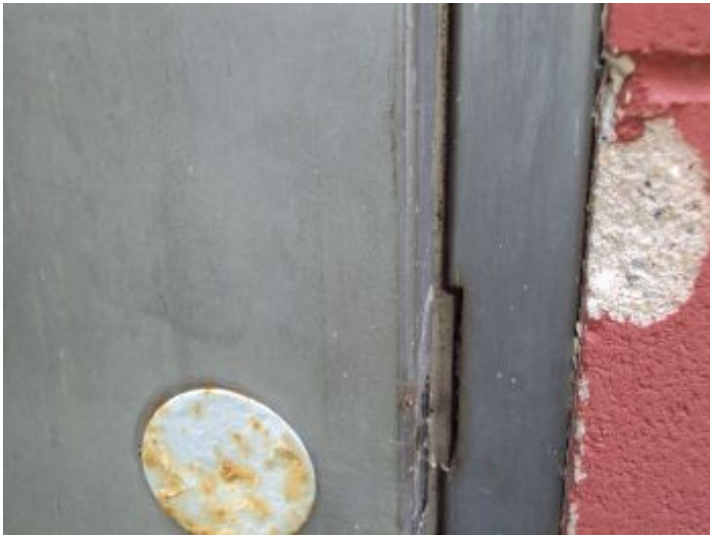
- Main Entry door is a wood door with a painted finish.
- Fascias are aluminum clad wood.
- All of the exterior hinged emergency egress doors are out of adjustment, rubbing, or have incomplete or damaged hardware items. We recommend having a qualified door contractor provide cost estimates and perform the necessary repairs.

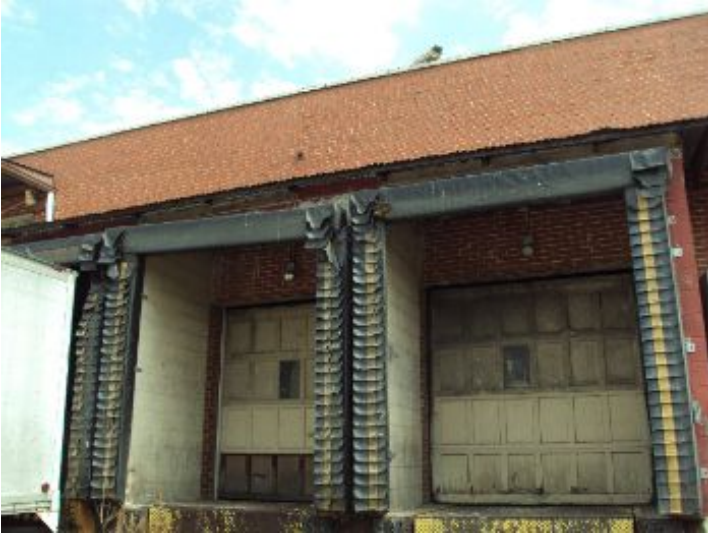
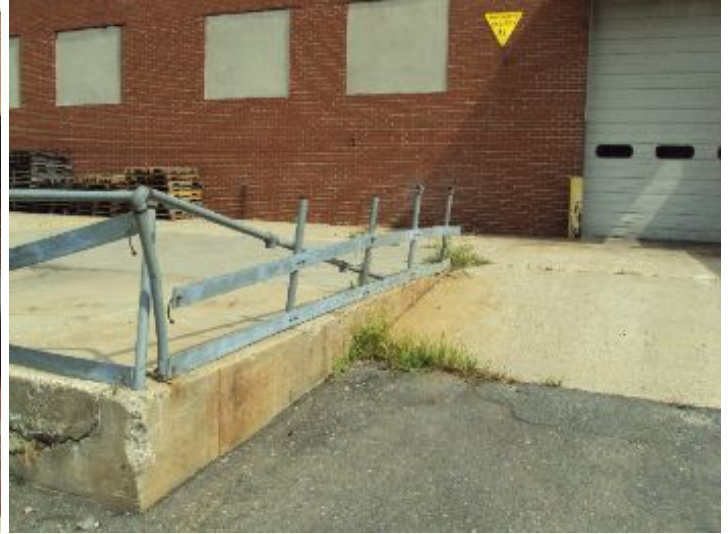
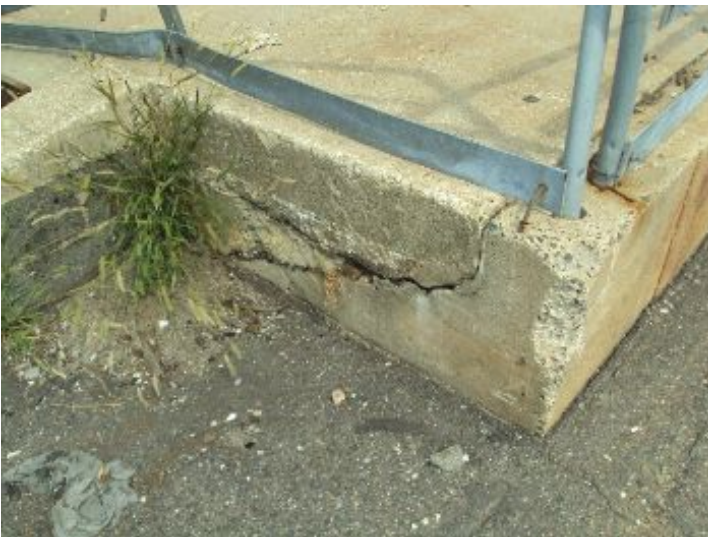
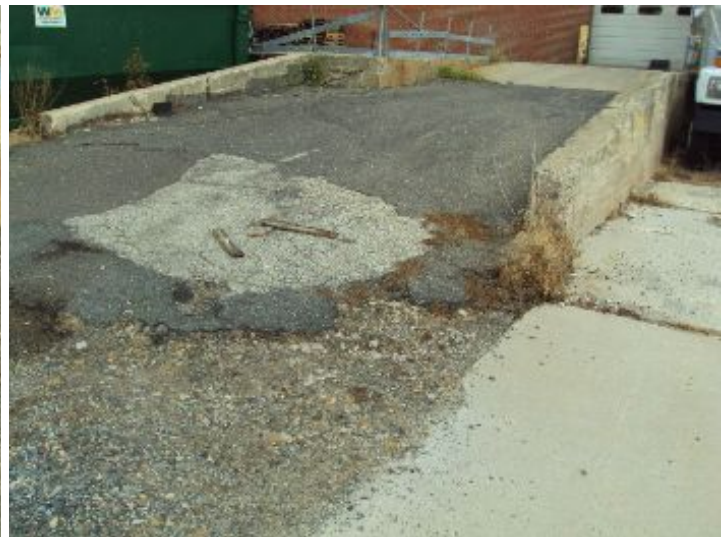
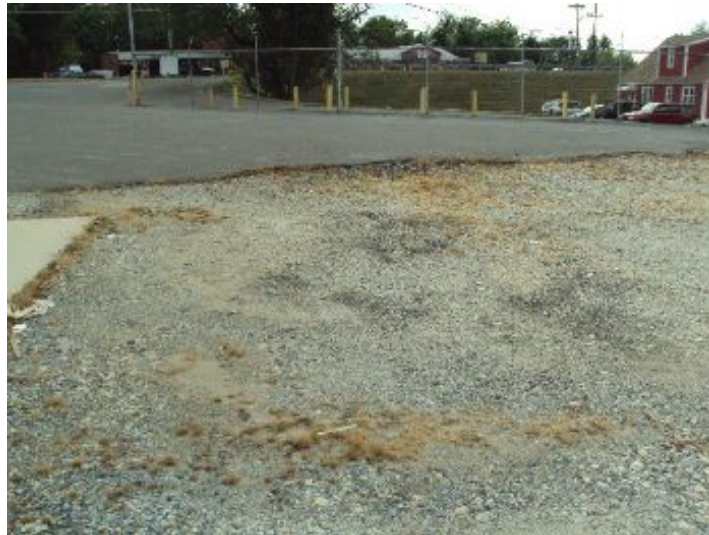
- The parking areas are a combination of improved asphalt, unimproved asphalt and un-maintained gravel parking areas. There is no lane or space striping present, nor are handicap parking places marked.
- Loading areas and loading docks are in disrepair at the exterior.

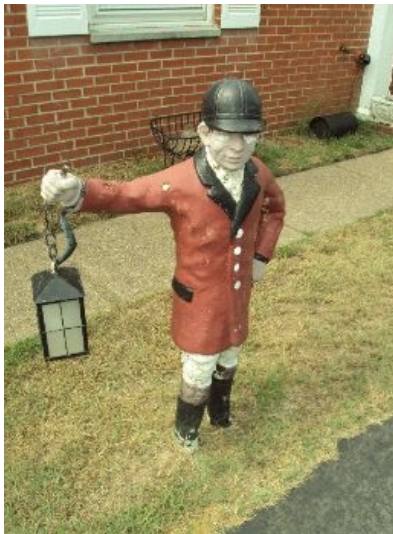
- The ornamental lighting in the front of the building did not operate with normal controls at the time of inspection. We recommend confirming their operation with the seller prior to closing.

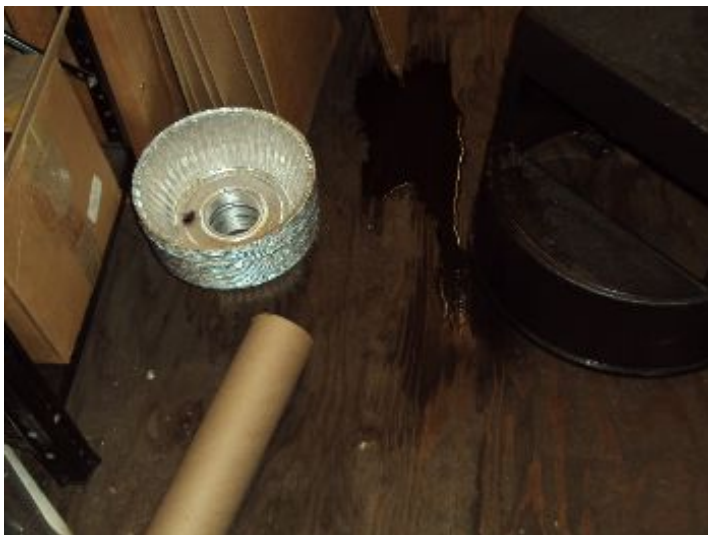
- Due to the prior and the on going roof leaks, the structure may be showing signs of decay on the upper level plywood floor. There are numerous damaged ceiling tiles on the lower level. We recommend having a qualified contractor perform a more invasive evaluation of the structure which is beyond the scope of this inspection.

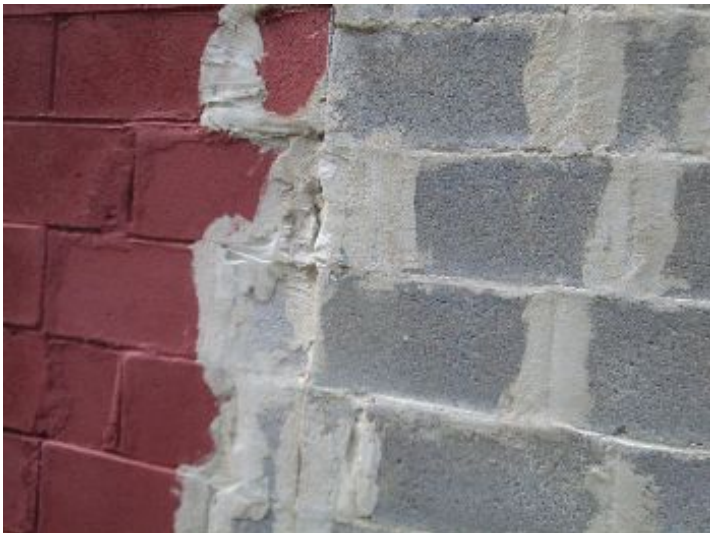
Poor workmanship

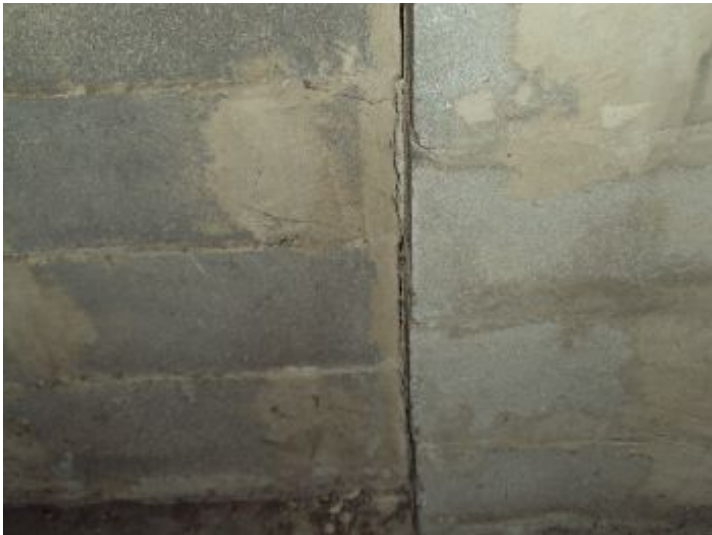
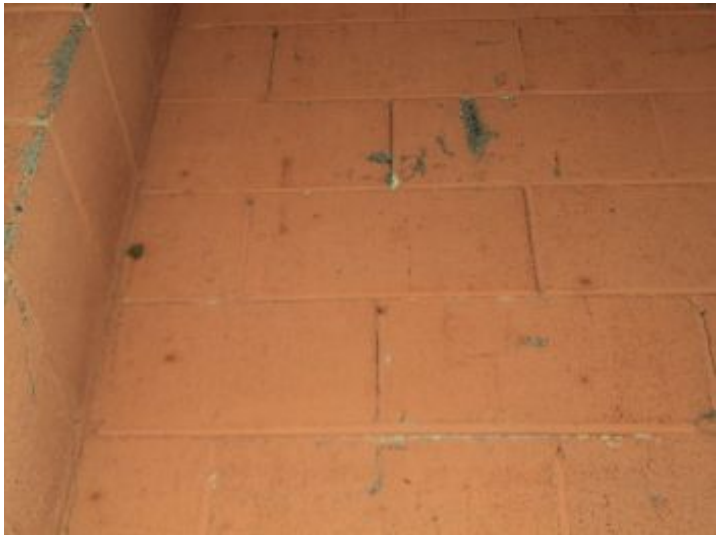
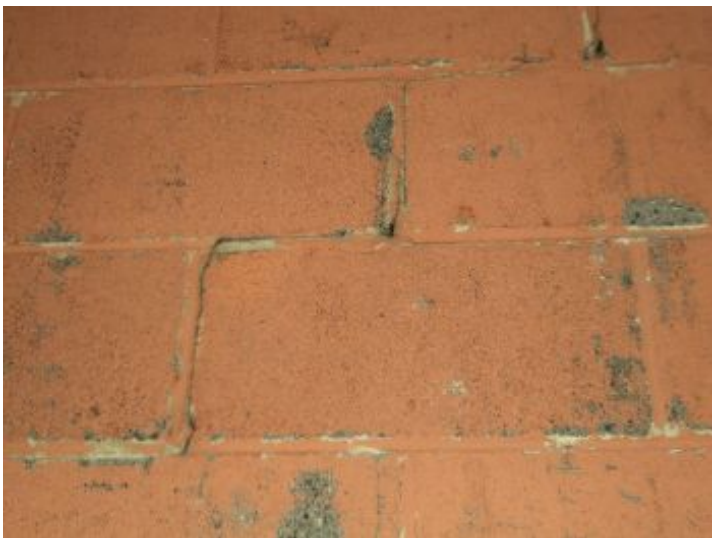
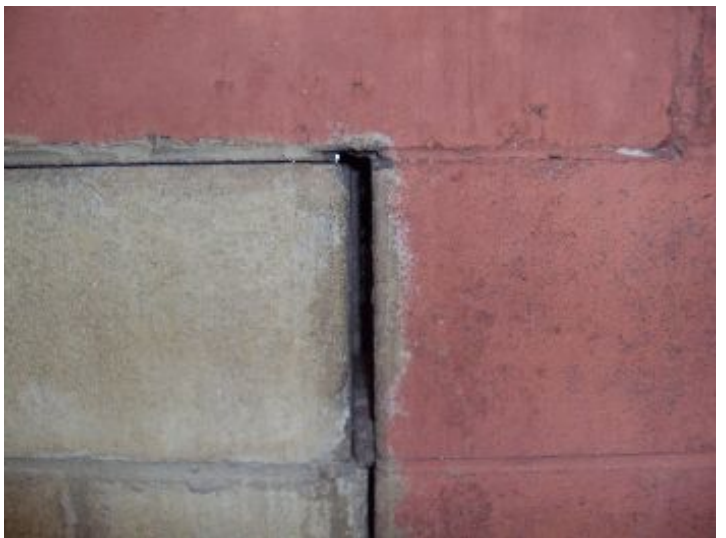
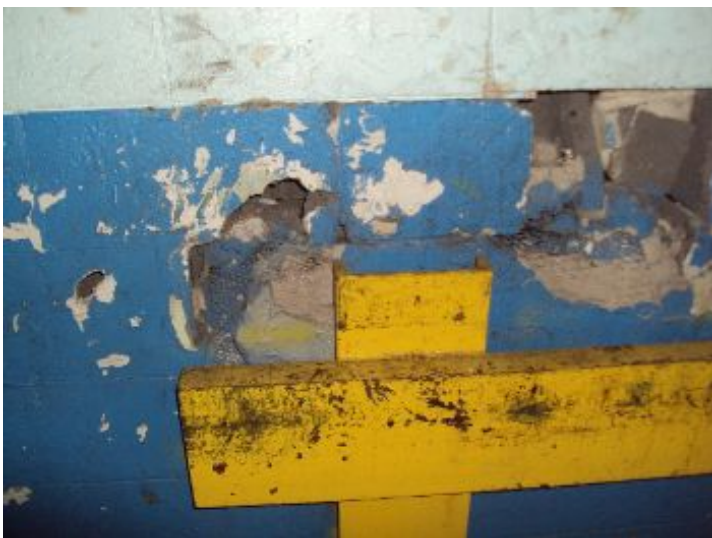
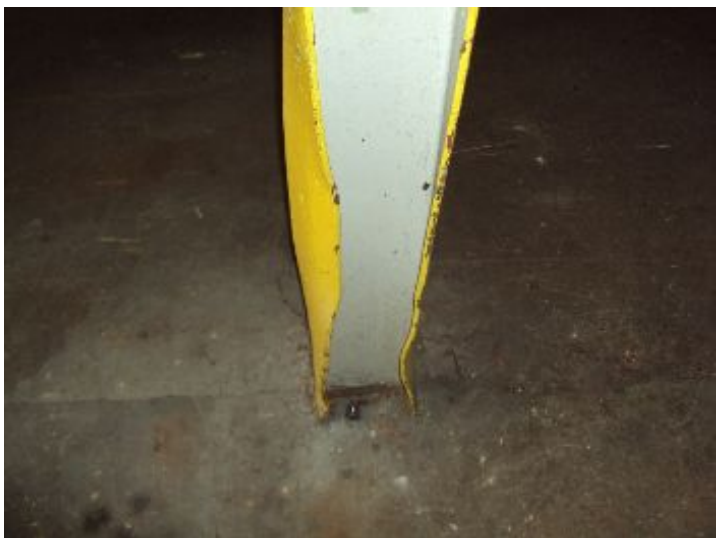
Masonry wall damage.

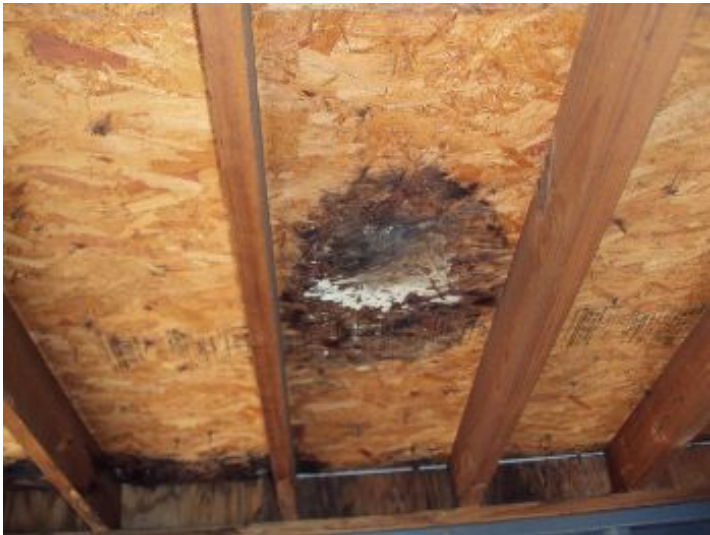
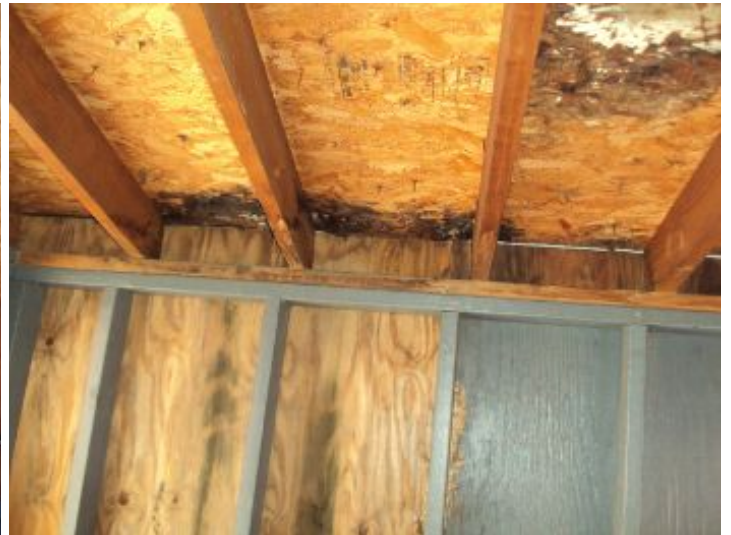
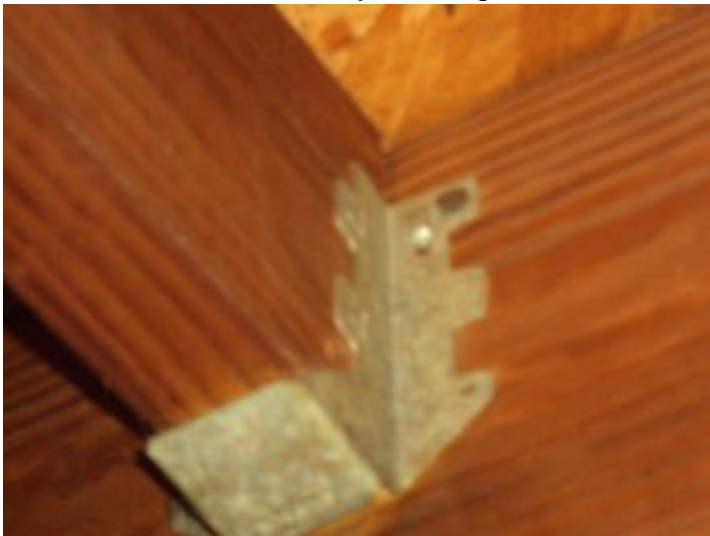
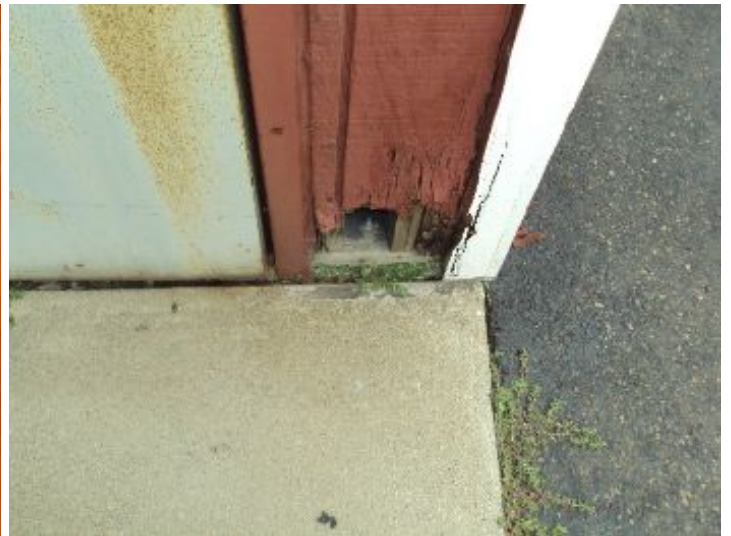
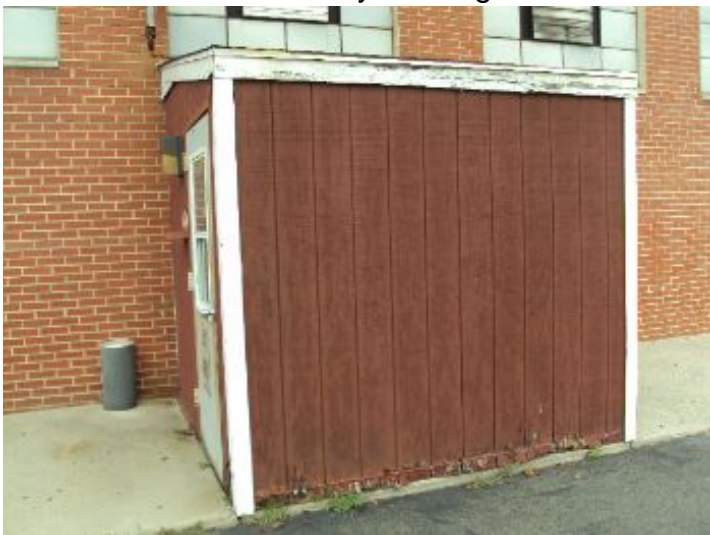
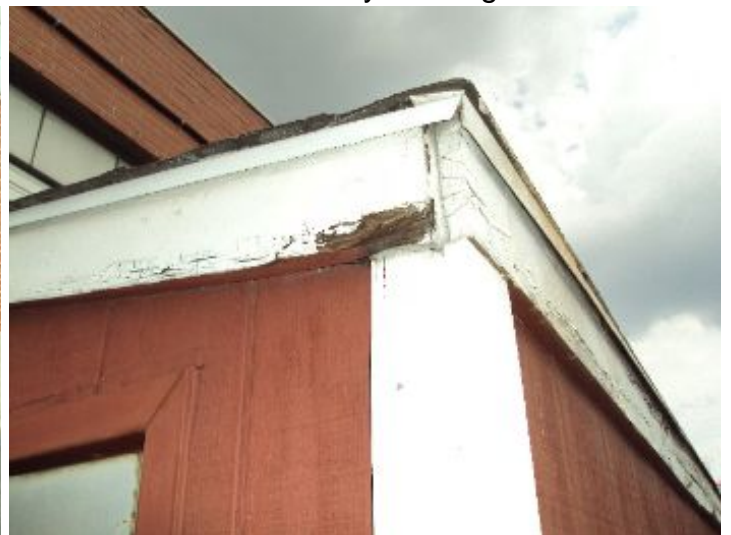
- The attached wood constructed accessory structures attached to the left side of the building are in disrepair dur to deferred maintenance and water damage. We recommend budgeting for replacement.

Accessory building

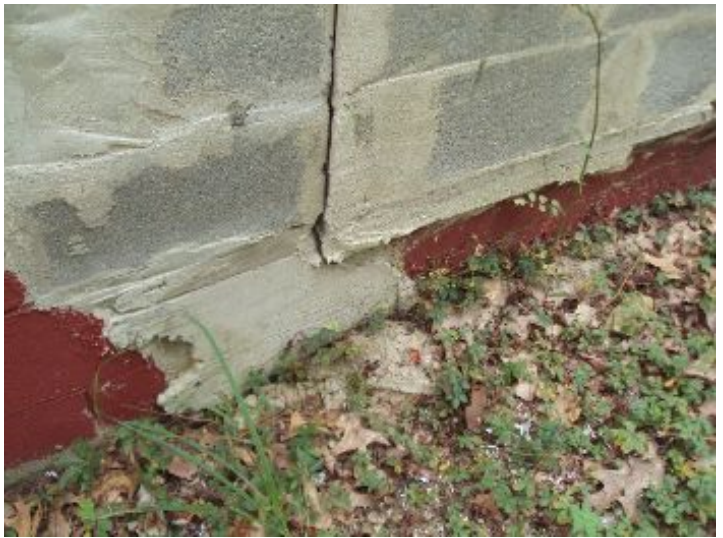
Poor workmanship

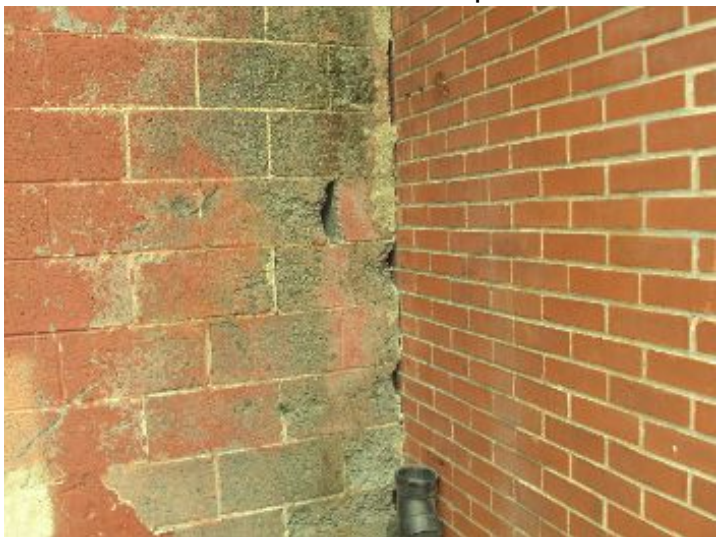
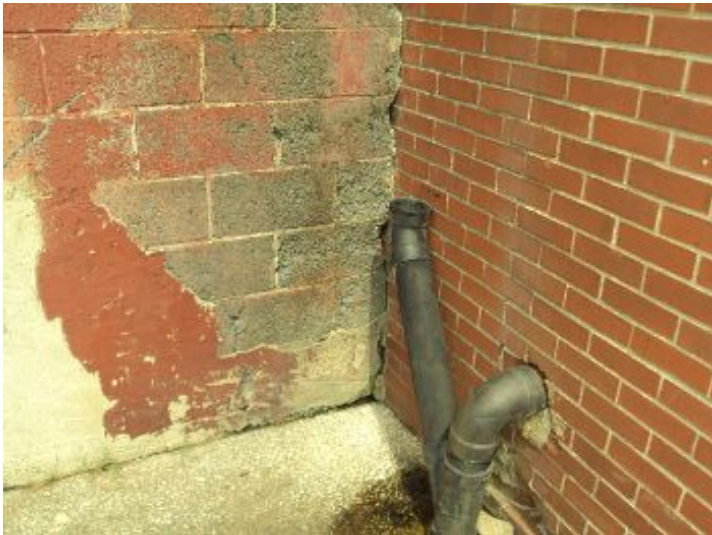
Spalling

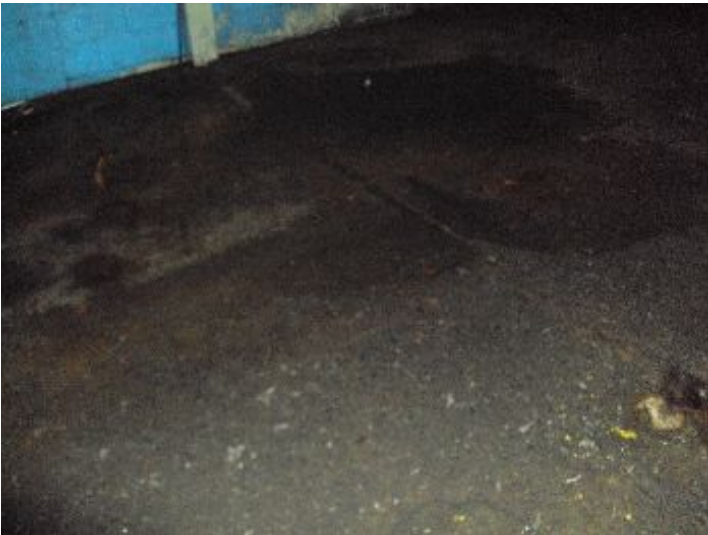
Observations:  
• Efflorescence observed; this is a mineral deposit left behind from exterior water infiltration.  
• There is evidence of moisture penetration in the manufacturing area. We recommend having a qualified contractor repair as necessary.

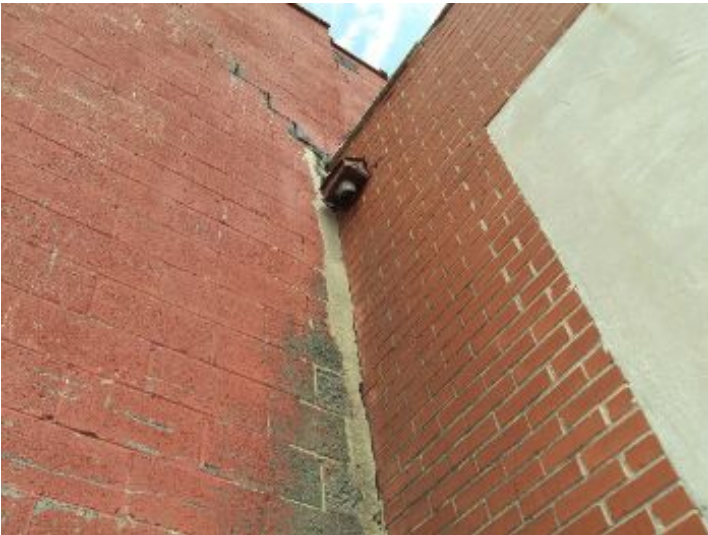
Observations:  
• Step cracks in the corners of the foundation are present. This is an indication of irregular settlement and movement.

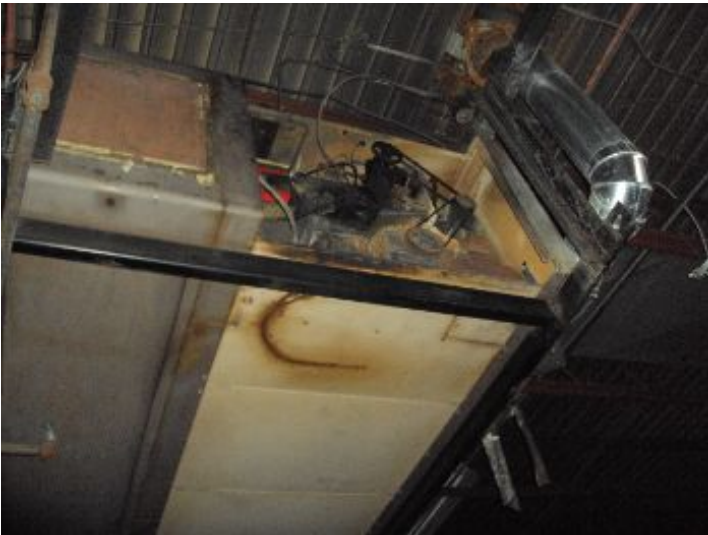
- Office area:
  - Natural gas fired unit.
  - Remote thermostat
  - The heating system was operable at the time of inspection using normal operating controls.
- Manufacturing area:
  - Natural gas fired unit.
  - Fuel oil fired unit.
  - Remote thermostat
  - No thermostat noted.
  - The main oil-fired furnace in the manufacturing area runs without a thermostat. The method of turning the unit on and off is to use the circuit breaker that controls it. Circuit breakers are not intended to be used as on-off control switches. This will probably lead to failure of the breaker itself. We recommend having a qualified contractor install proper operating controls for the unit.

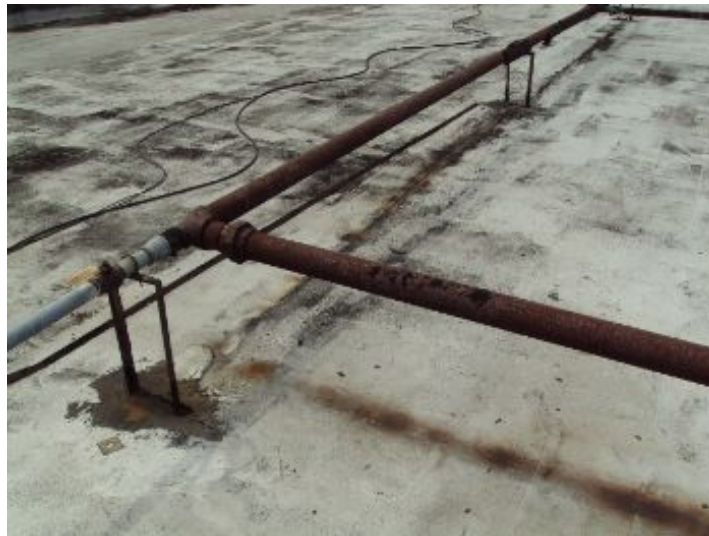
- Overhead gas piping is not identified by marking tape or streamers. Recommend as a safety requirement marking the gas piping with approved gas utility marking tape.

Scrape and paint gas piping at the roof

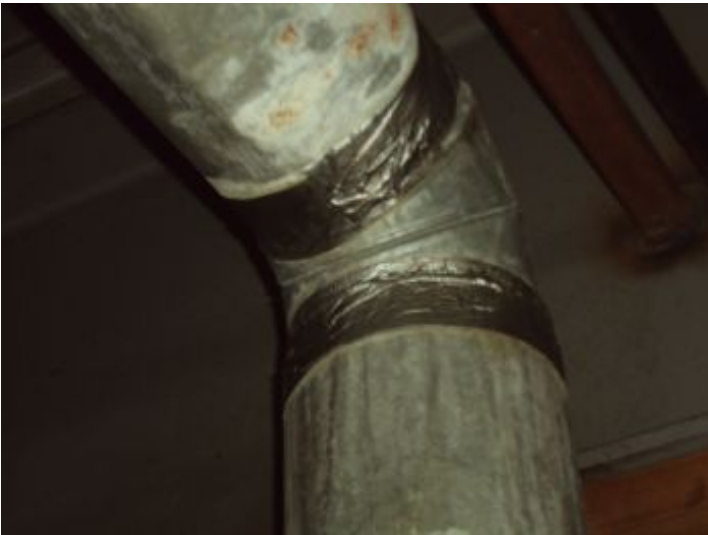
- Much of the ductwork stemming from the roof top HVAC units is sealed at the connections with cloth backed duct tape. This tape is known to deteriorate and become ineffective over time. We recommend having a qualified HVAC contractor repair all joints in the ductwork that are affected by this tape with a duct sealing mastic.

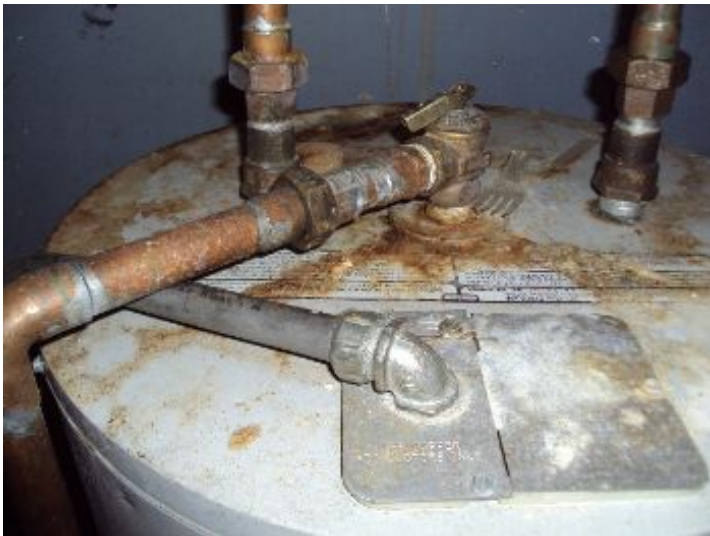
- The water heater is a 40 gallon electric model that is located in the mens locker room in the utility closet. The exact age could not be determined from the data plate. The unit although functioning as intended at the time of inspection however, shows the wear and tear that could be expected from a unit that has reached the end of its useful life expectancy. We recommend having a qualified plumbing contractor provide replacement options and cost estimates.
- The water heater that is located in the break room does not have the proper support under it. The cabinet that it sits in is deteriorating and failing.

Prior leaks and deterioration

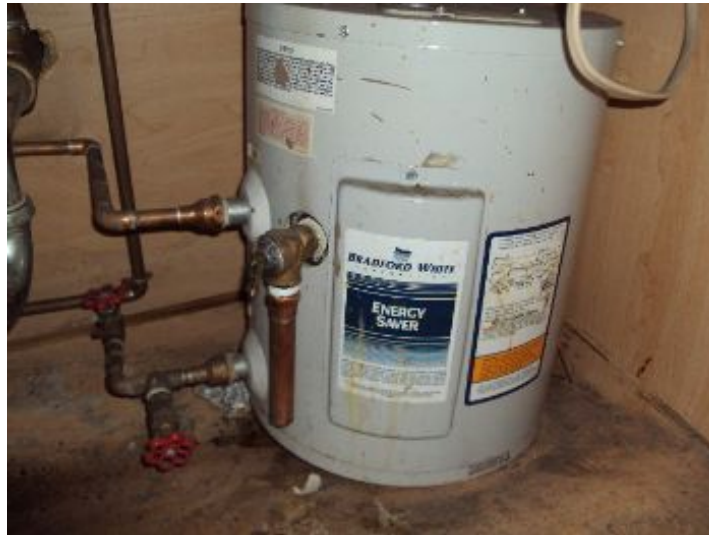
Water heater support damaged.

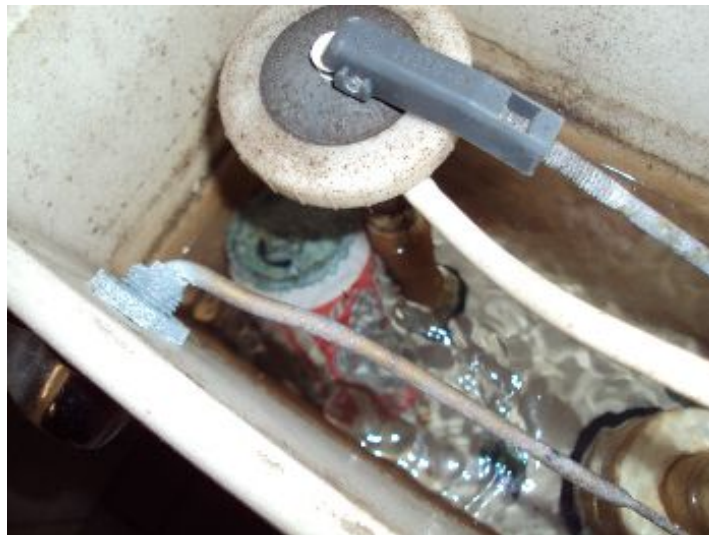
- No major system safety or function concerns noted at time of inspection.
- We recommend removing the beer can and all other debris from the toilet tanks in the Mens locker room prior to using the bathrooms.

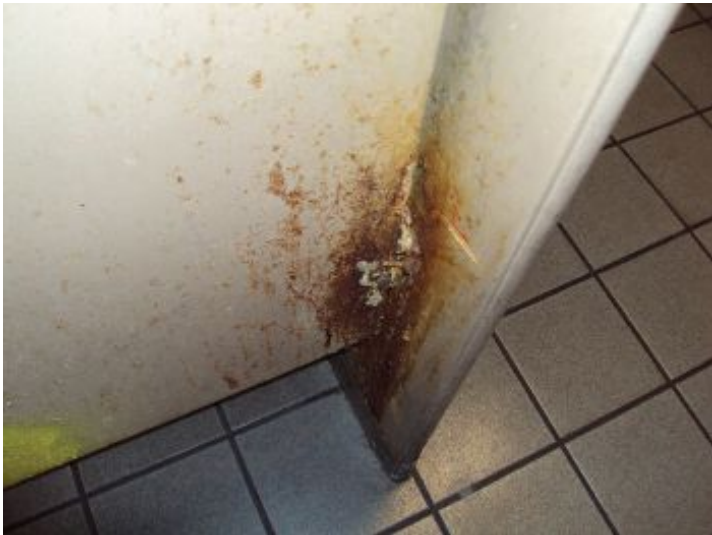
- The toilet partition doors in the Mens Locker Room do not latch securely. One door has a broken strike plate and the other has a missing strike plate.
- Many of the toilet partitions in the Men's and Women's Locker Rooms are damaged by rust and corrosion. We recommend budgeting for replacement of these.

Toilet partition door doesn't latch (Mens Locker Room)

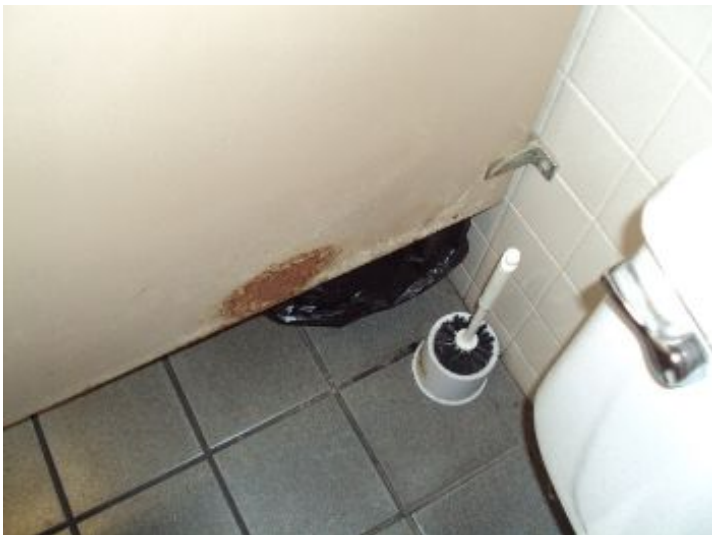
Toilet partition damage

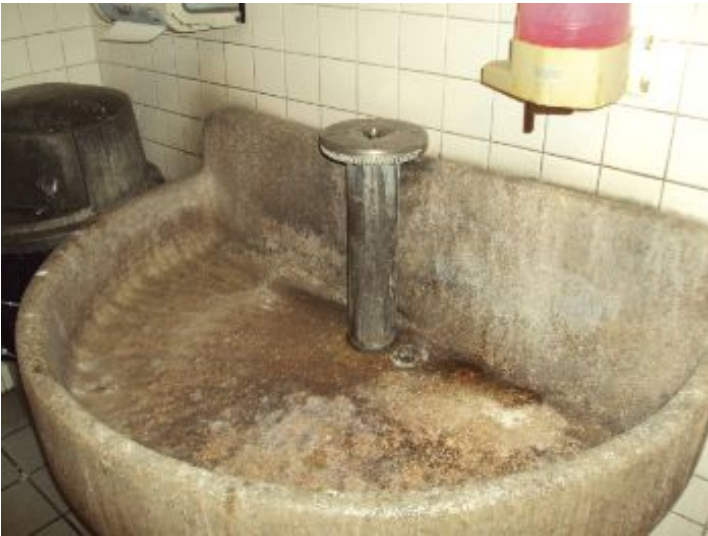
Evidence of a prior repair (Mens Locker Room)

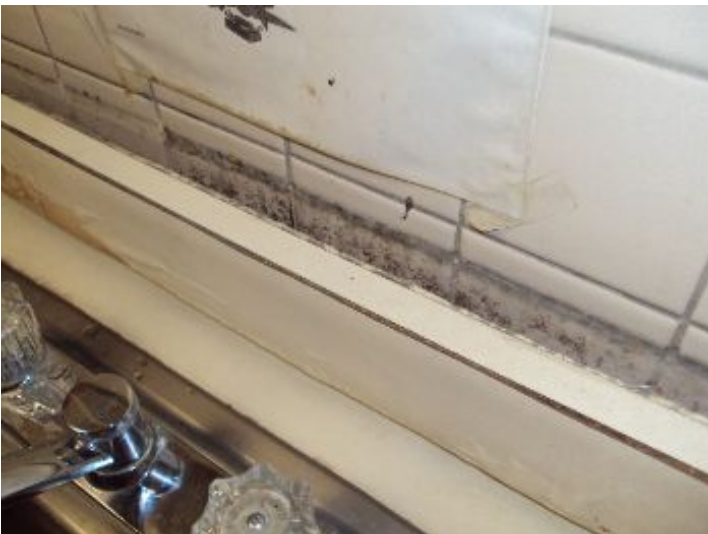
Backsplash water damaged and coming loose

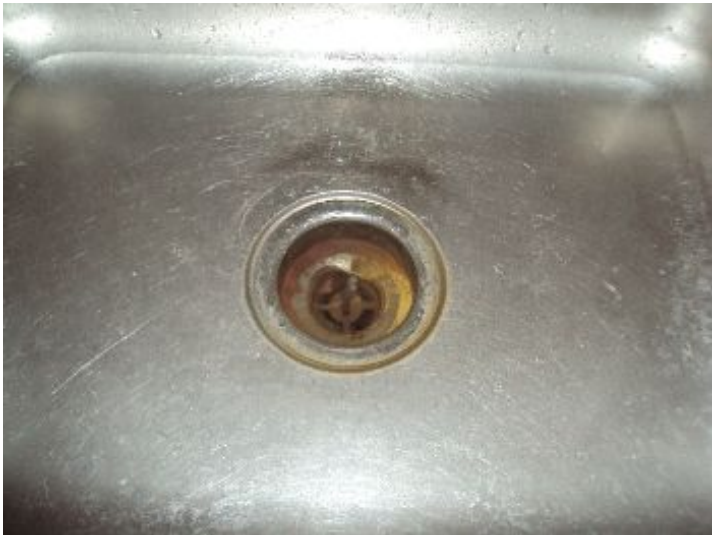
Sink drains poorly.

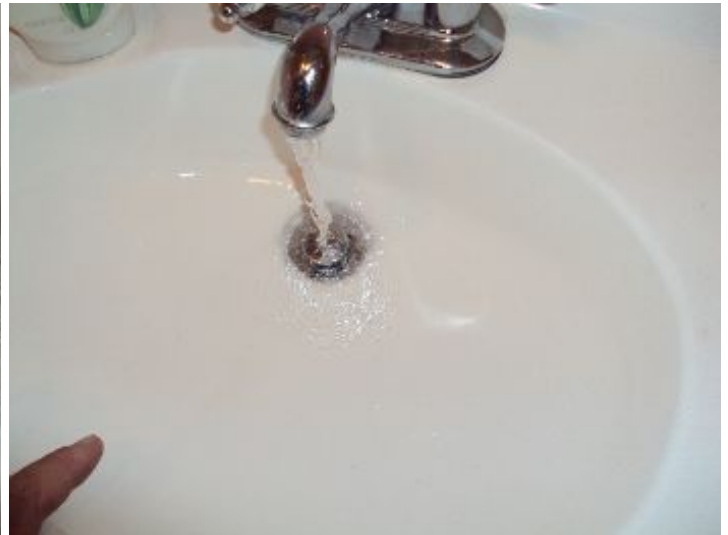
Stopper does not work

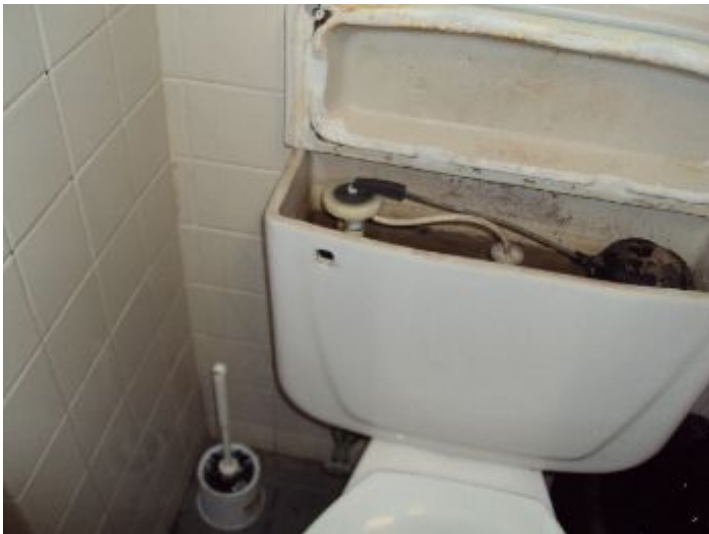
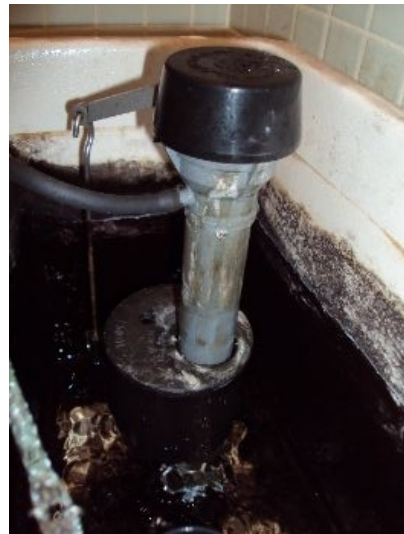
- There is a leaking fill valve in the Presidents office private bathroom. We recommend having a qualified plumbing contractor replace the valve.
- The Womens Locker Room toilet has a missing flush handle. Have a qualified plumbing contractor replace as necessary.
- We recommend removing the beer can and all other debris from the toilet tanks in the Mens locker room prior to using the bathrooms.

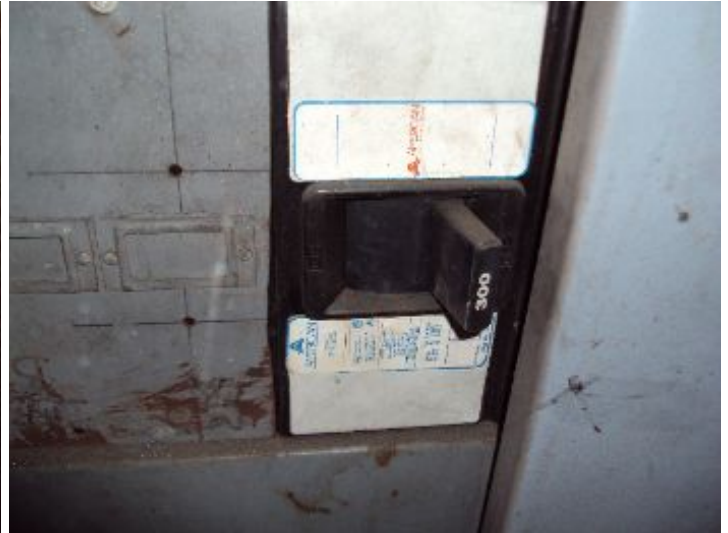
There are two 300 amp circuit breakers located at the main switch gear that are not in service. These breakers, if not being used should have lock-out devices installed so they cannot be accidentally energized.

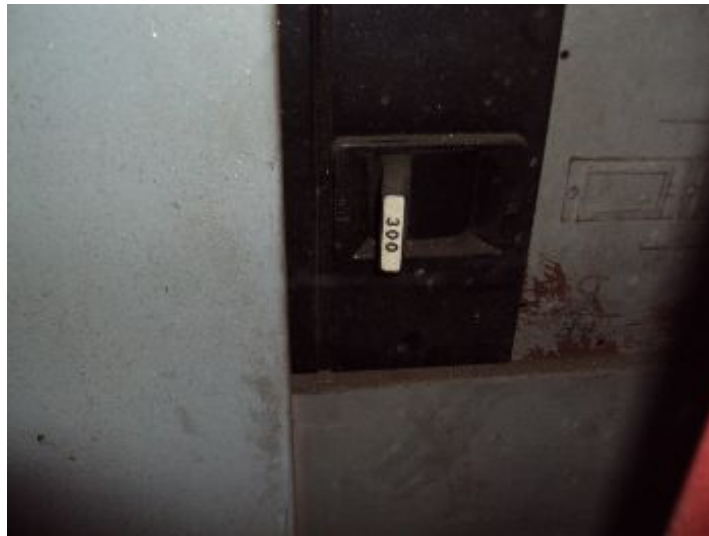
There are two 300 amp circuit breakers located at the main switch gear that are not in service. These breakers, if not being used should have lock-out devices installed so they cannot be accidentally energized.

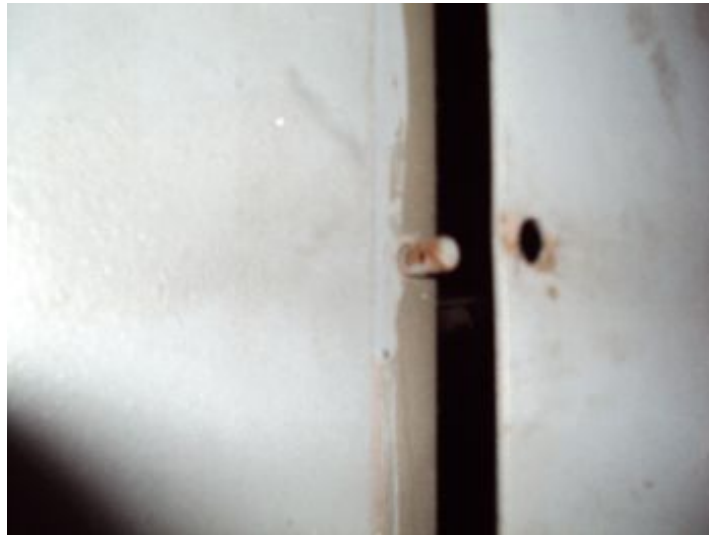
- Switch gear present
- Ct cabinet present
- Switch gear cabinet does not have a lock on it. Due to the excessively high voltage in these cabinets, a lock is necessary as a safety precaution. Recommend locking the cabinet as soon as possible.

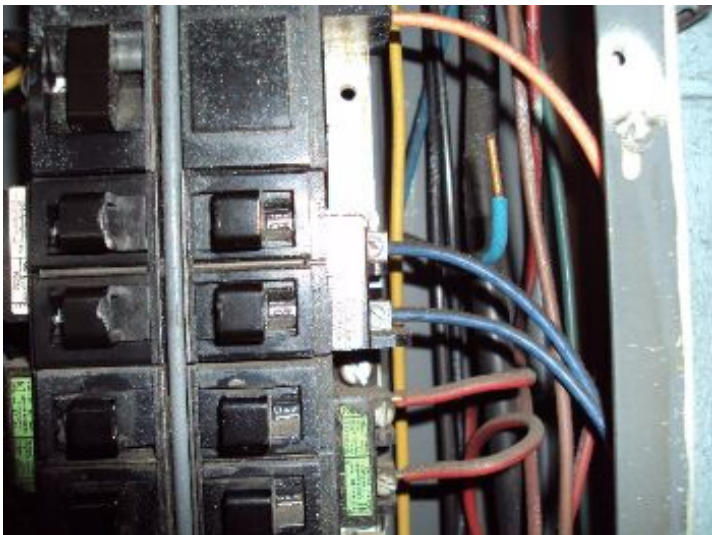
Stray, Unidentified wire in panel (B)
