# Homespect LLC

## Commercial Inspection Report

600 Commercial Way, Your Town NJ  
Inspection prepared for: Commercial Client  
Inspection Date: 8-16-2010 Time: 10:00 AM Size: 42, 315 sf  
Weather: Cloudy, 90's

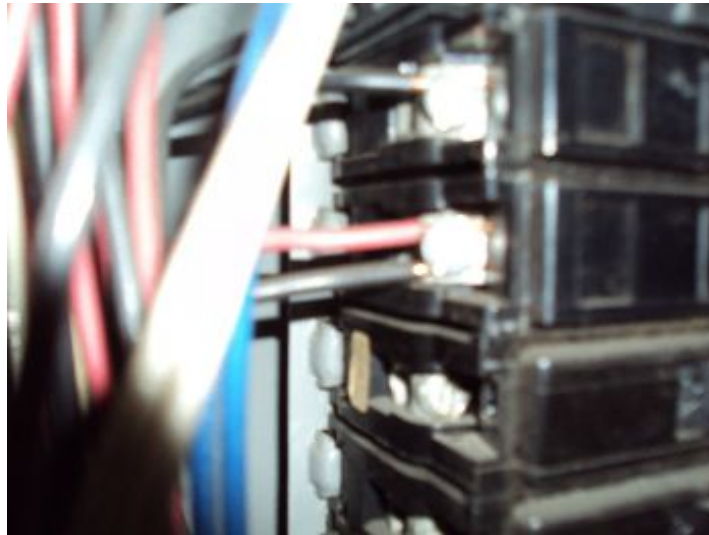
Double tapped breaker noted.

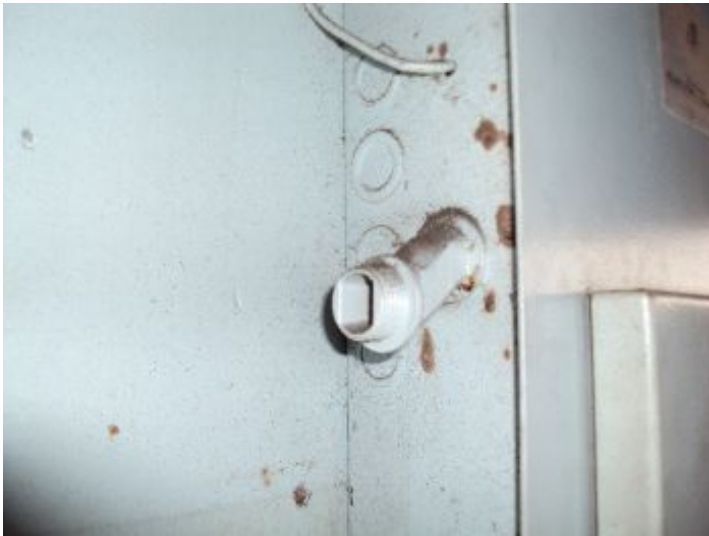
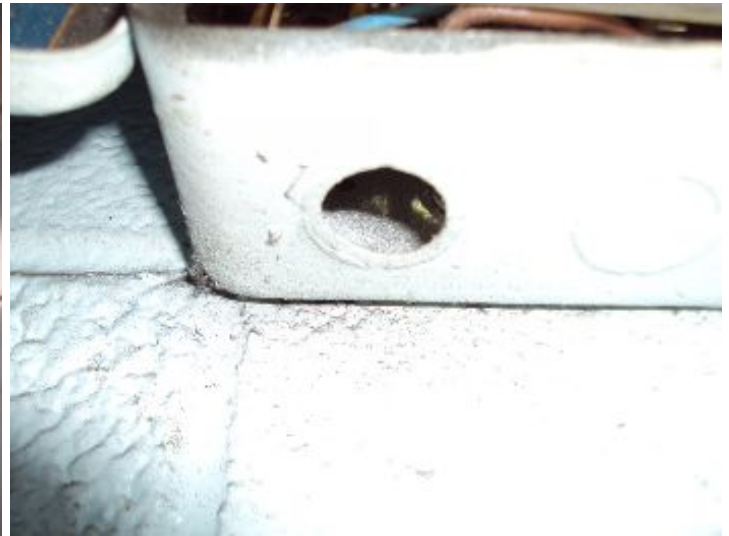
- The electric panel back box has open knock out holes which need the appropriate knock out seals put in them at panels A&B

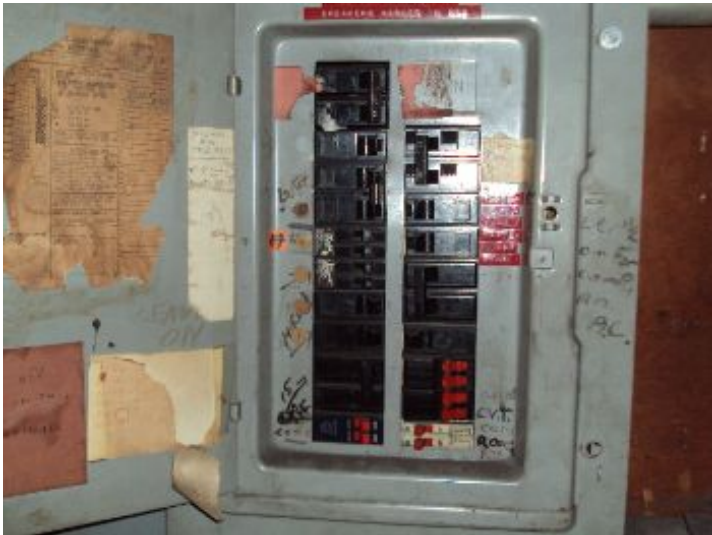
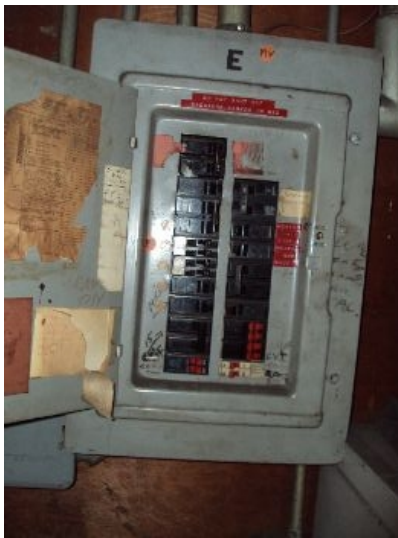
- Most of the panels are poorly or incorrectly labeled. We recommend having a licensed electrician trace all circuits and properly label all panels.

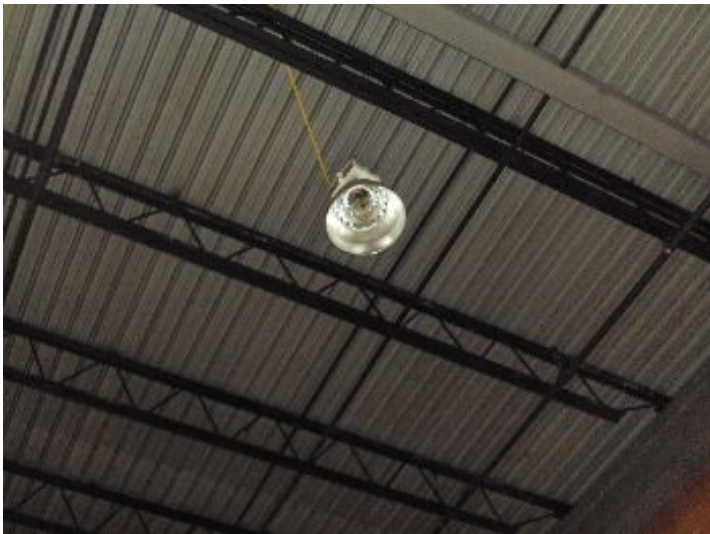
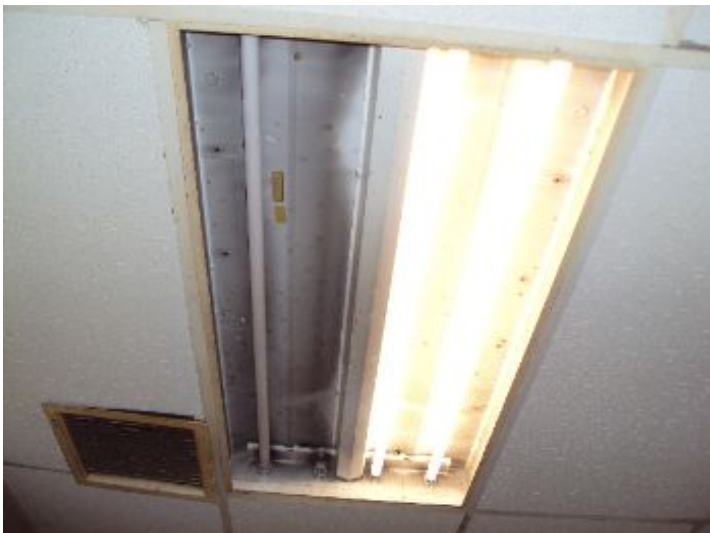
- A large portion of the lighting in both the office area and the manufacturing area are not working , or in some state of disrepair. We recommend having a licensed electrician repair and or replace as necessary.

Improper wiring

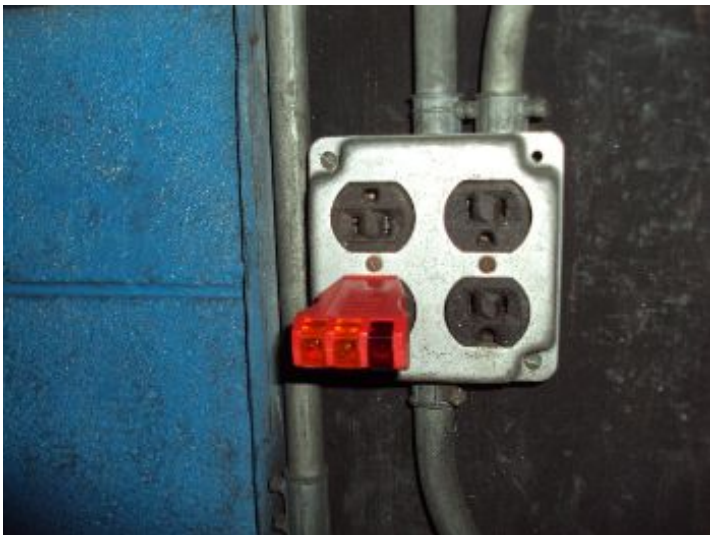
- There are a number of outlets noted that are inoperable at the time of inspection. We recommend having a licensed electrical contractor either remove these or repair as necessary to make them operational.
- There are a number of switches and or outlets noted that are not properly secured or fastened at the time of inspection. This is a safety hazard and should be corrected. We recommend having a licensed electrical contractor either remove these or repair as necessary to reduce the danger of an electrical shock.

Dread outlets

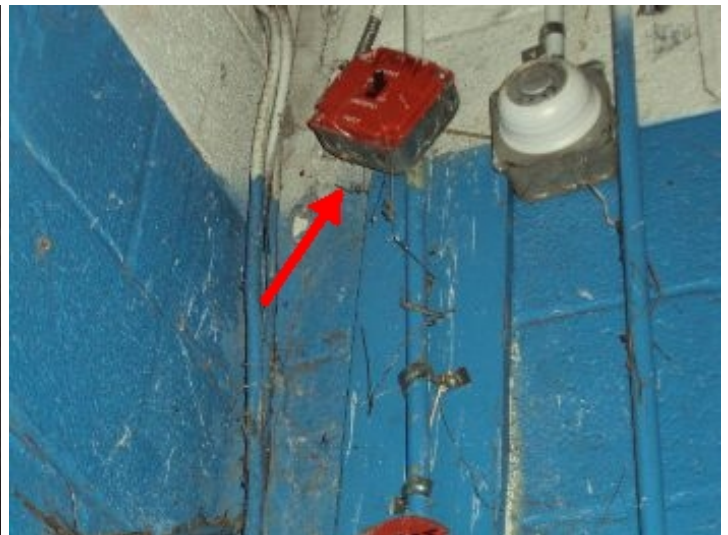
Unsecured switch

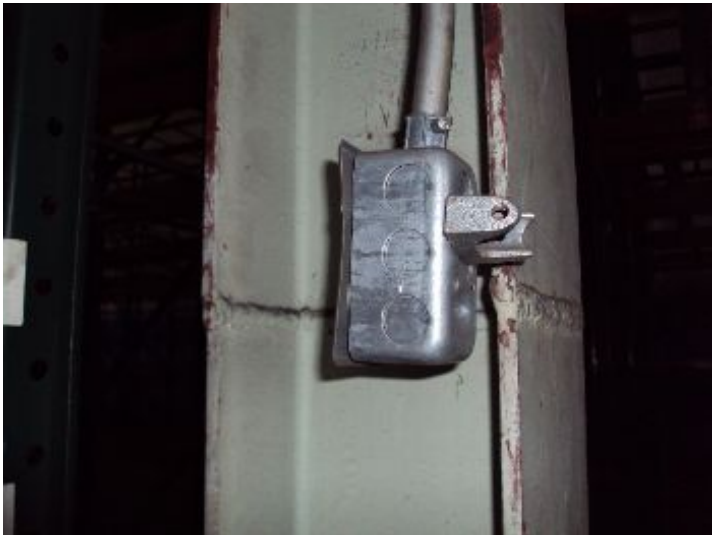
Unsecured outlet

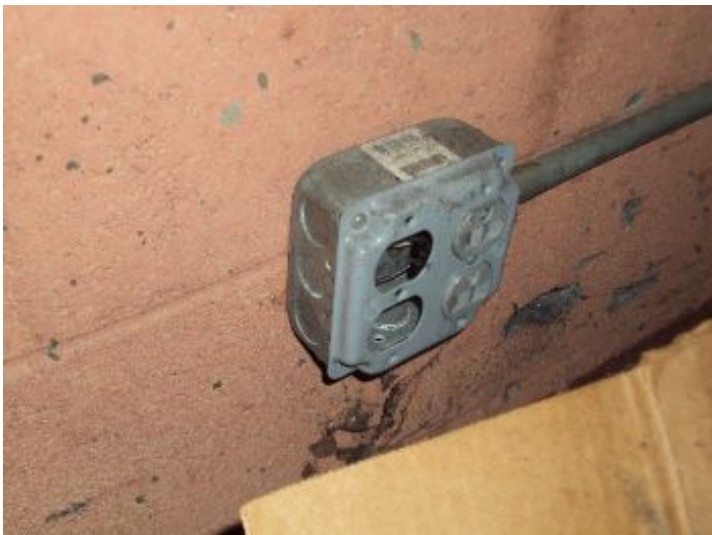
• Outlets in both the office and the manufacturing space are missing cover plates. This is a potential safety hazard. We recommend replacing the outlet covers.

Missing cover in office space

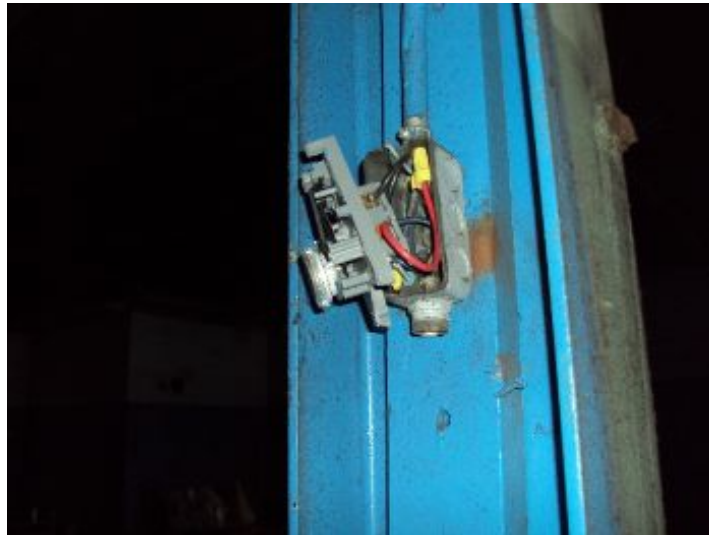
• Open "live" junction and device boxes noted at the time of inspection. This is a safety hazard and should be corrected ASAP by a licensed electrical contractor.

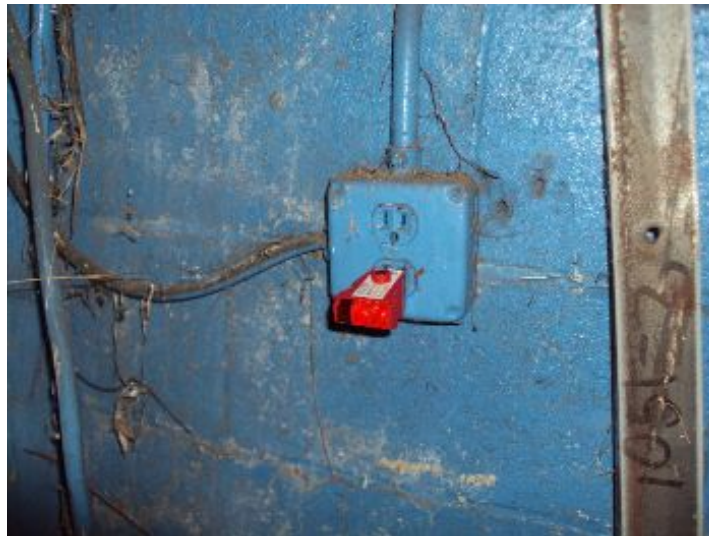
• There are outlets noted that are painted over and are still operational. This is not an accepted practice and should be replaced by a licensed electrical contractor.

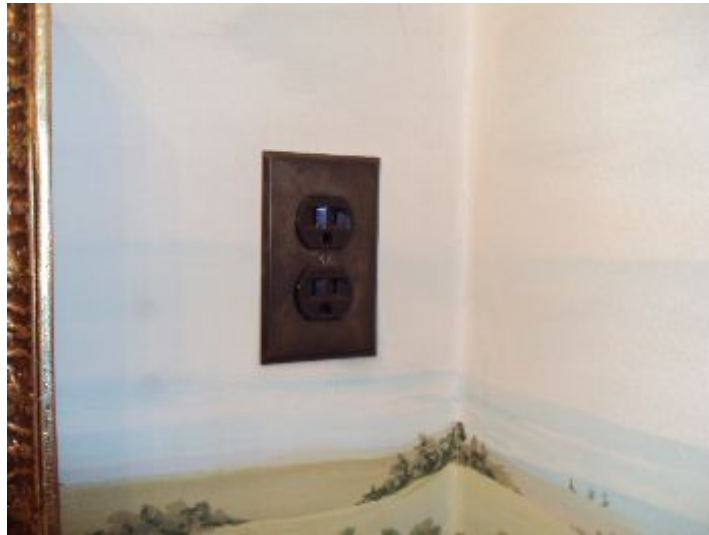
• The receptacle in the Presidents bathroom is a non-GFCI outlet. We recommend replacing the outlet with a GFCI as an upgrade.

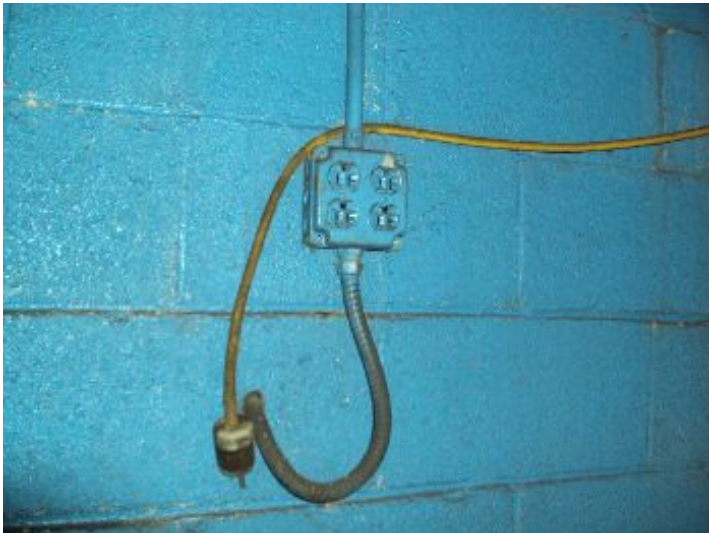
- A flexible cord connected security light was noted at the time of inspection. This is an improper wiring method used for this type of fixture and should be removed.
- There is a water heater in the break room that is improperly plug and cord connected. This is an improper installation as this appliance should be hard wired. The wire used is not rated for plug and cord connectivity. This is a safety hazard and should be corrected as soon as possible. We recommend having a licensed electrical contractor repair as necessary.

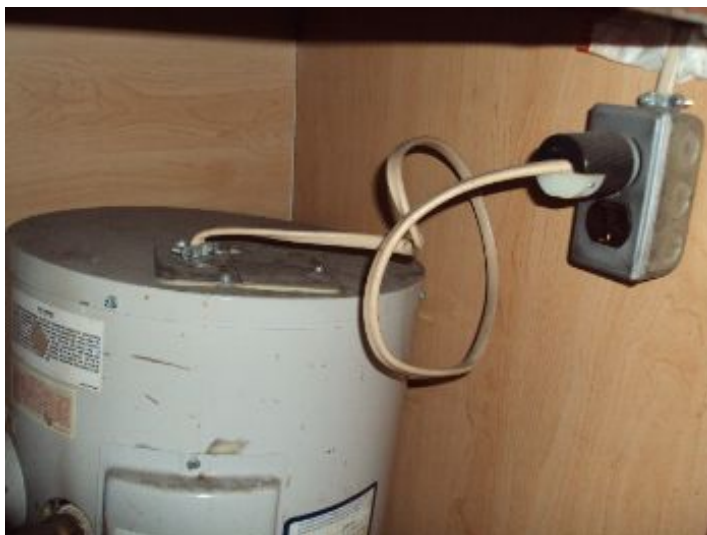
Cord connected water heater.

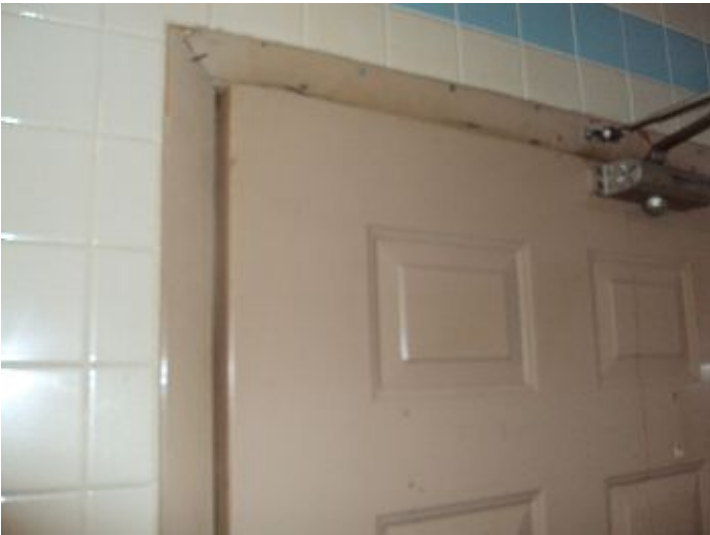
Men's room door does not close properly

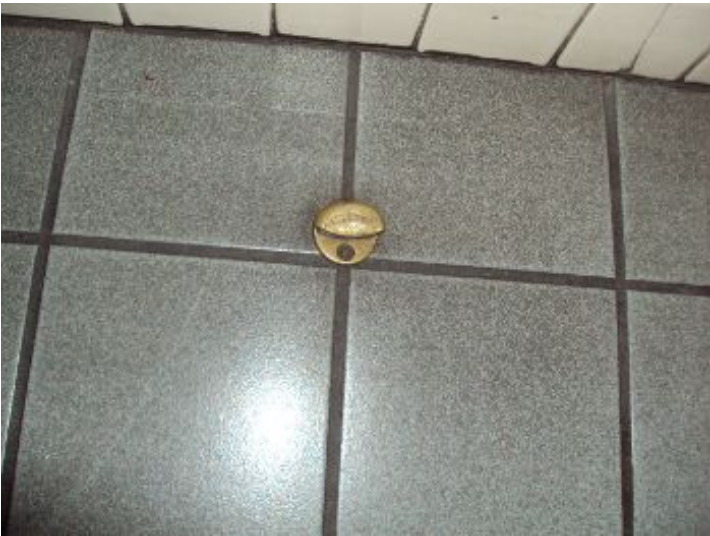
Door stop in womens room crushed and ineffective

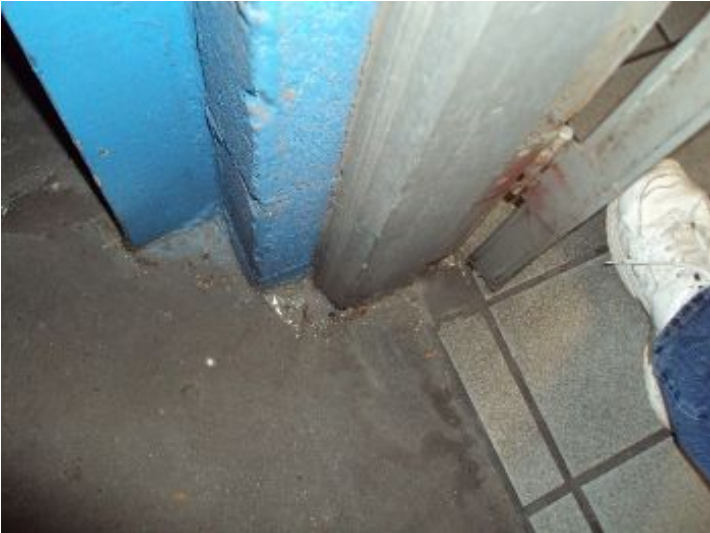
Decayed door frame

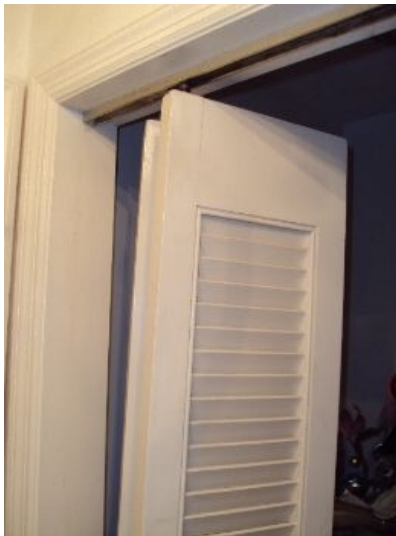
Door out of alignment

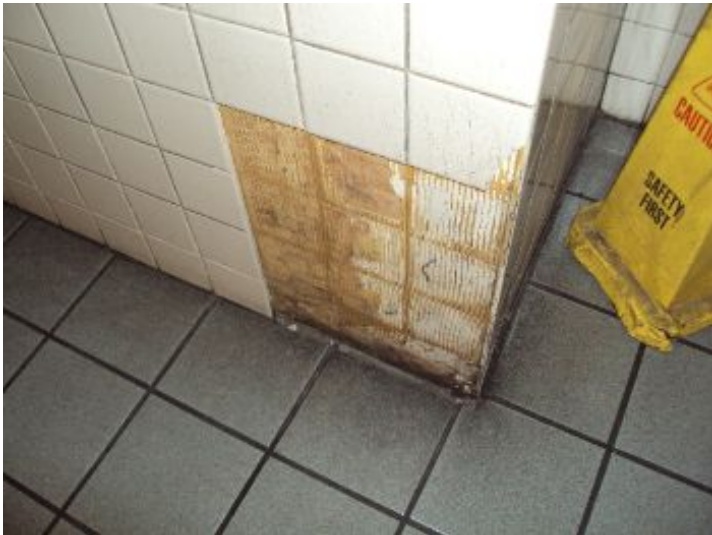
Ceramic tile missing from women's room wall.

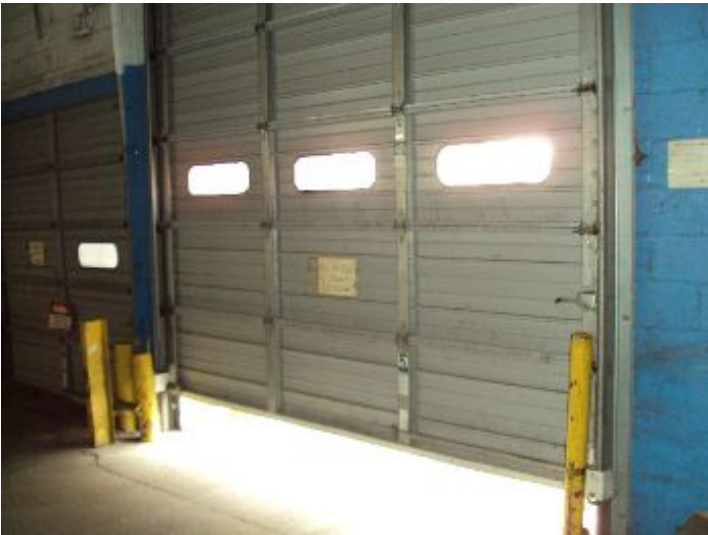
• The loading dock garage doors did not work smoothly and required a great deal of force to operate. Broken hardware is noted on one door. We recommend having these doors serviced by a qualified overhead door contractor to bring them back into working order.

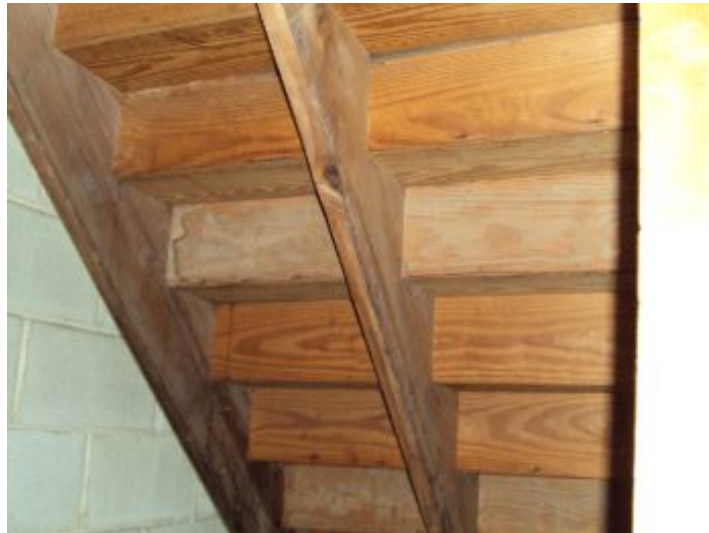
- The stairs leading to the storage loft space in the warehouse area has a stringer spacing of more than 16". The risers and treads are constructed of a nominal 1" thick material which should have a support spacing of no more than 16". We recommend having a qualified contractor provide repair options.
- The stairs leading to the storage loft space in the warehouse area has an open sided staircase without balusters on the open side of the stair. The open stair should have a graspable handrail system with balusters spaced with no more than 4" between them. We recommend having a qualified contractor provide repair options.

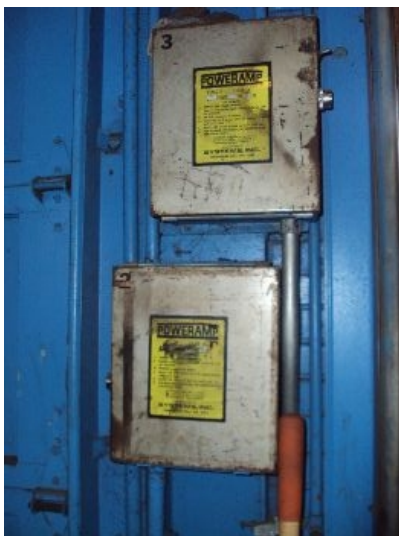
Dock leveler controls

- The loading dock levelers did not operate using normal controls at the time of inspection. We recommend having these levelers serviced by a qualified contractor, or confirm their proper operation with the seller prior to closing.

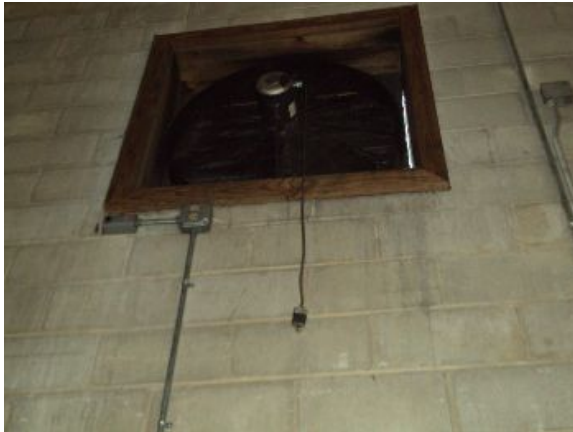
Ventilation fans not tested

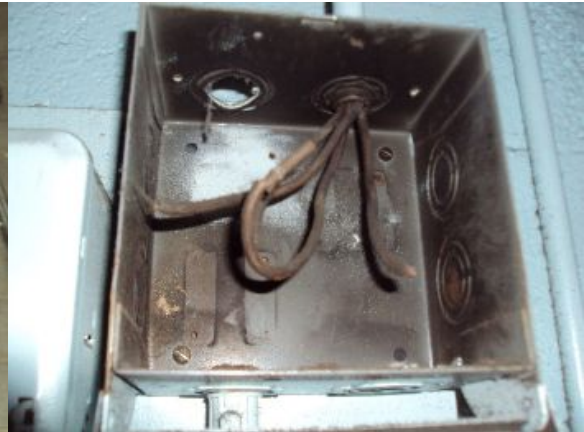
Abandoned electric in closed box

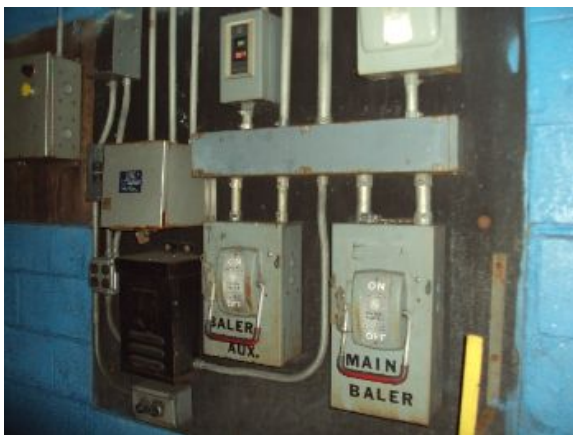
Baler controls not energized at the time of inspection

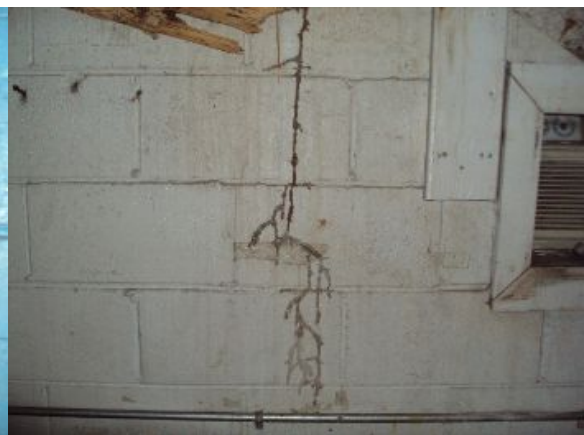
Termite shelter tubes in receiving office.

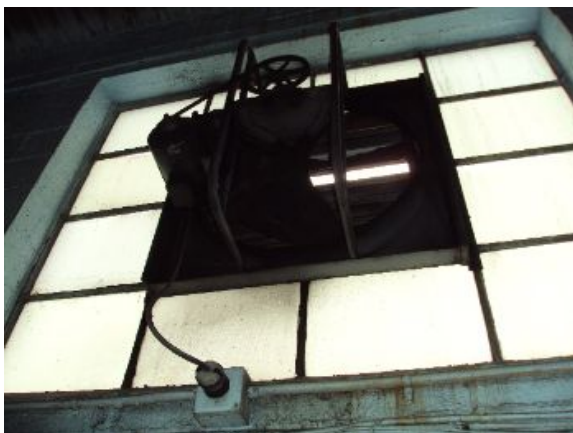
Exhaust fans not tested
